**Control of creeping water primrose
Ludwigia grandiflora
at Breamore Marsh, in New Forest District, Hampshire, UK**

**A report prepared on behalf of RINSE
(Reducing the Impact of Non-native Species in Europe)**

**Report prepared by
Hampshire and Isle of Wight Wildlife Trust
April 2013**

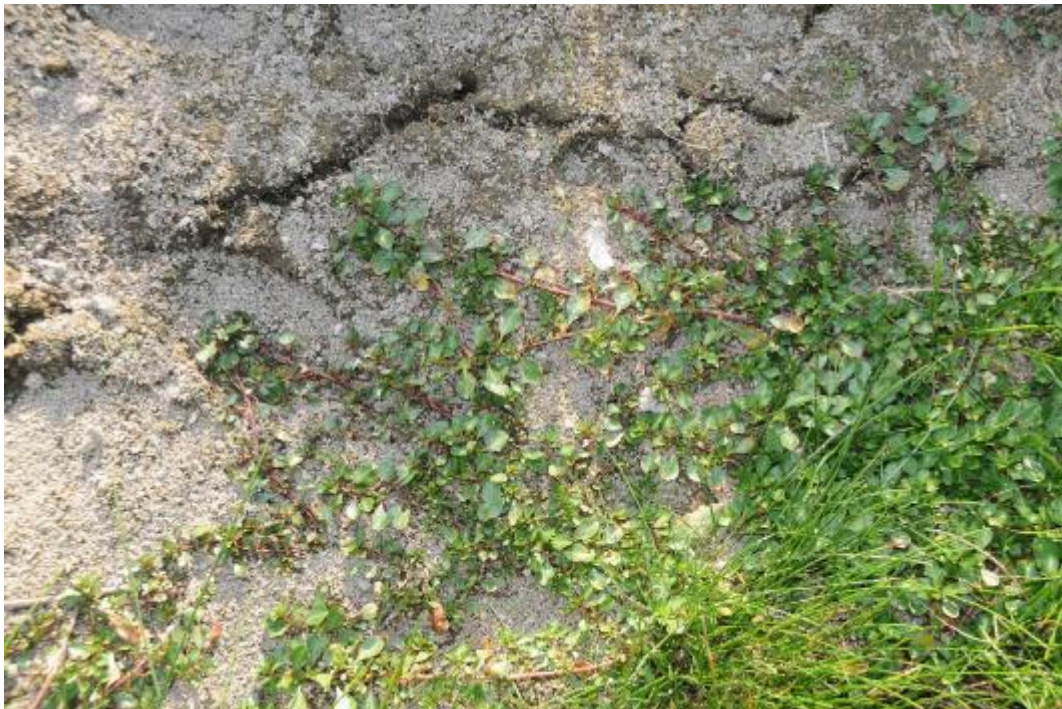
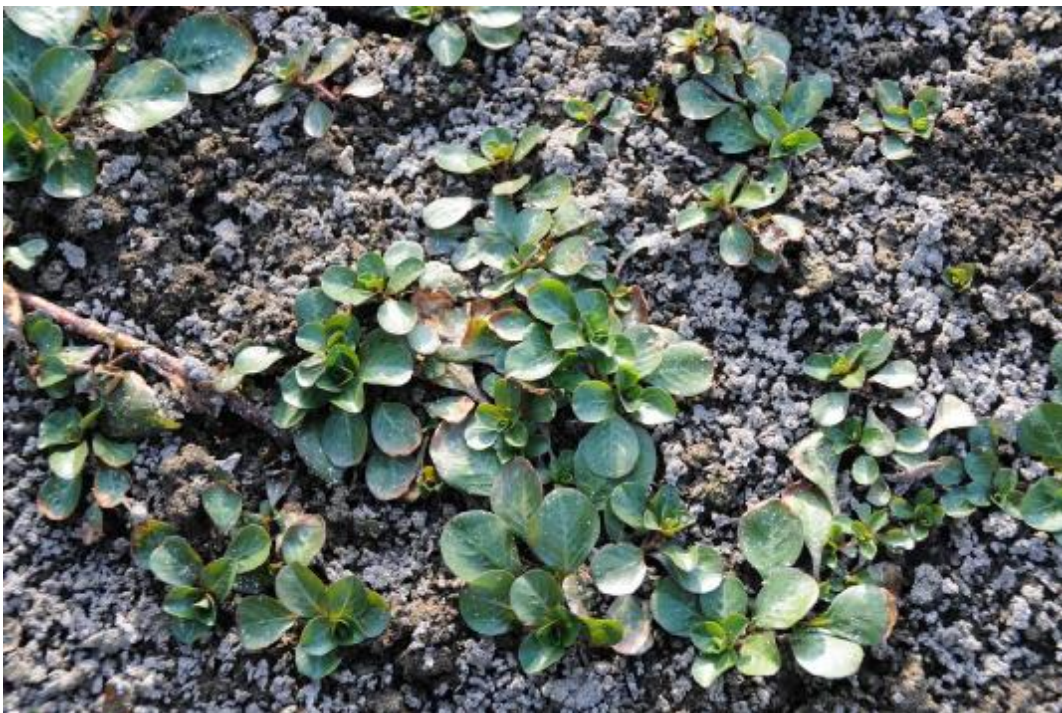
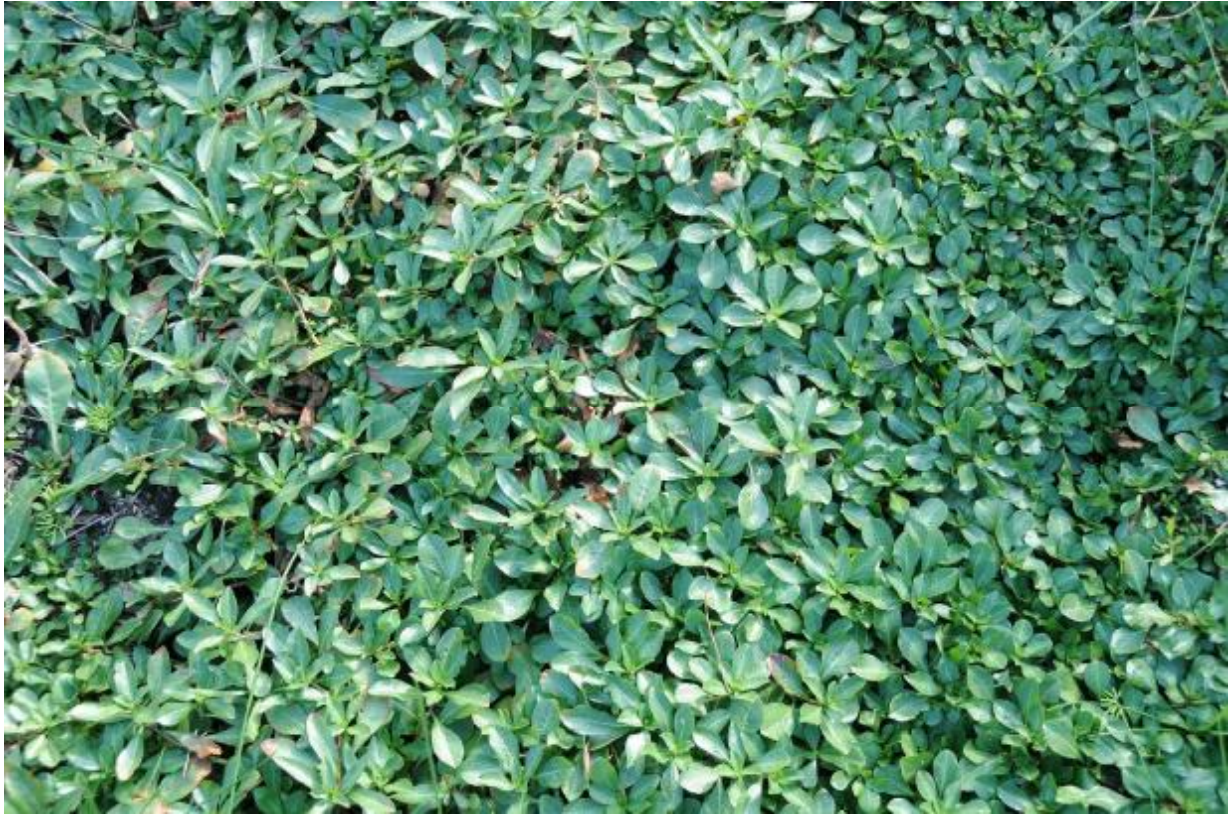
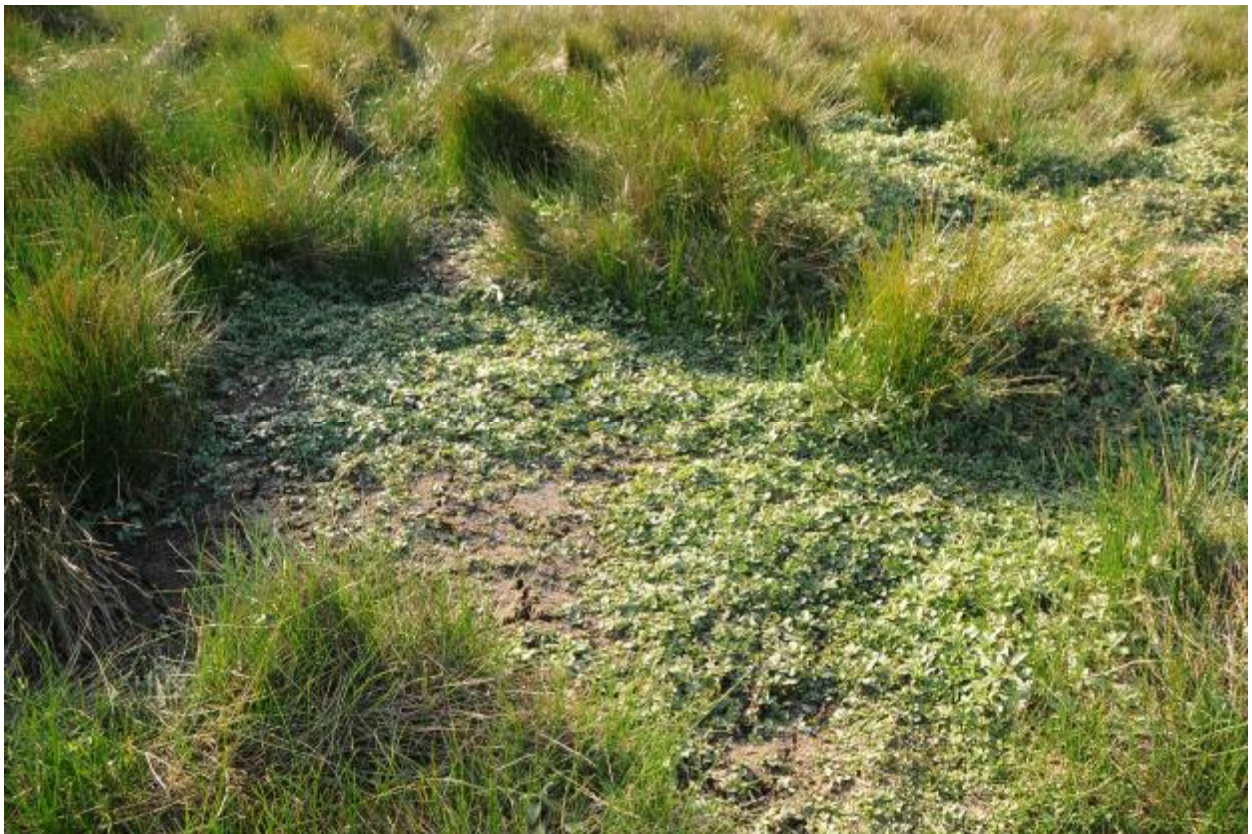
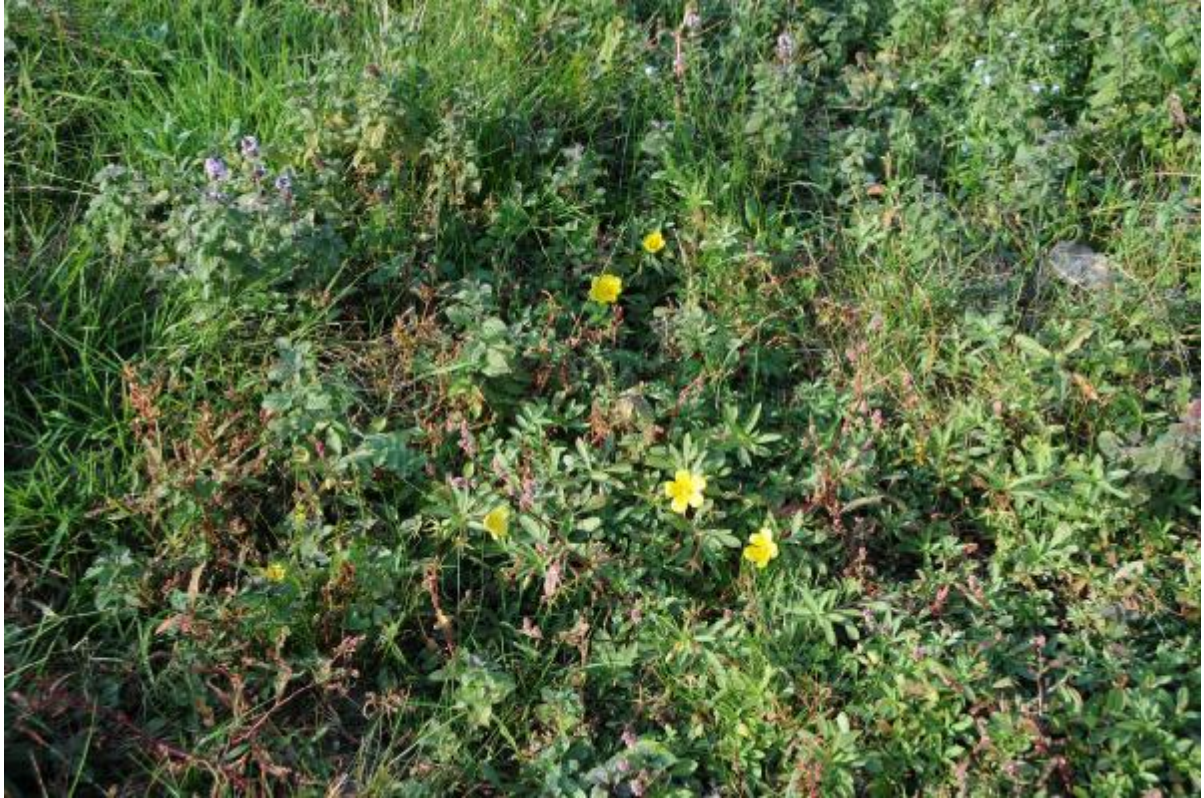
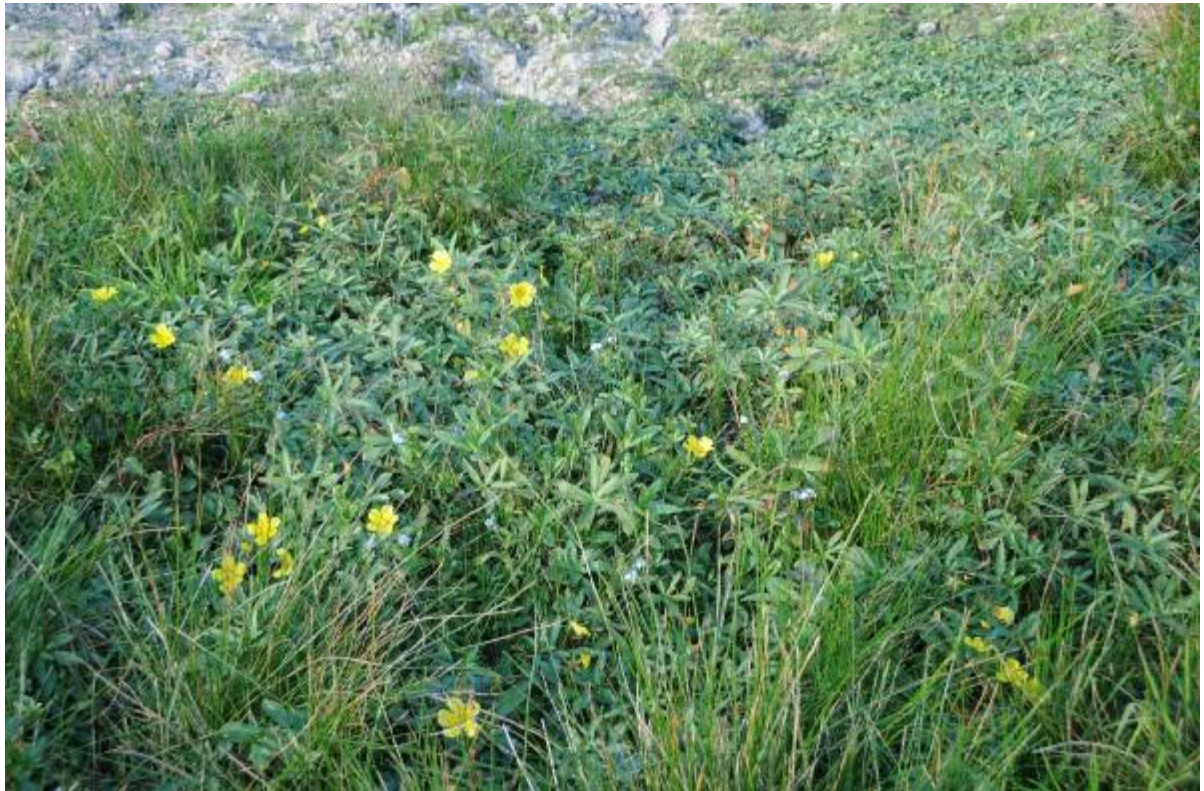
The *Ludwigia grandiflora* was dominant over large parts of Round Pond, spreading across bare mud, forming dense mats of foliage and flowering amongst other vegetation as shown in the following photographs:-

Ludwigia grandiflora photographed at Round Pond on 1 October 2009
(photographs: Trevor Renals)

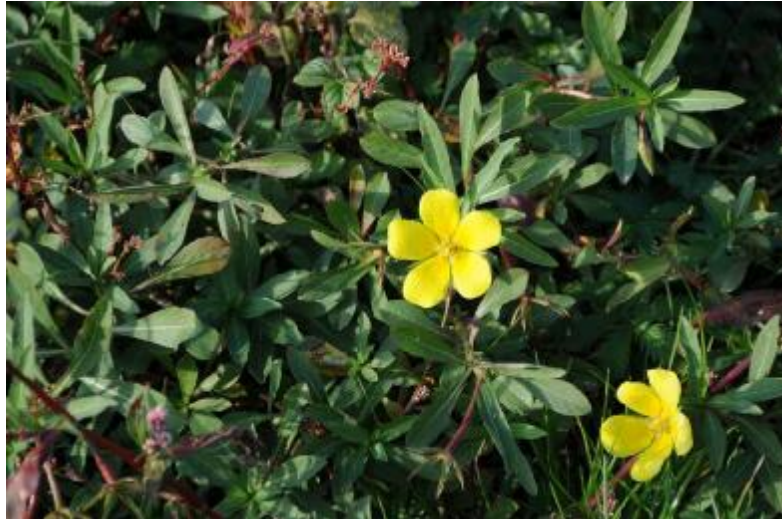
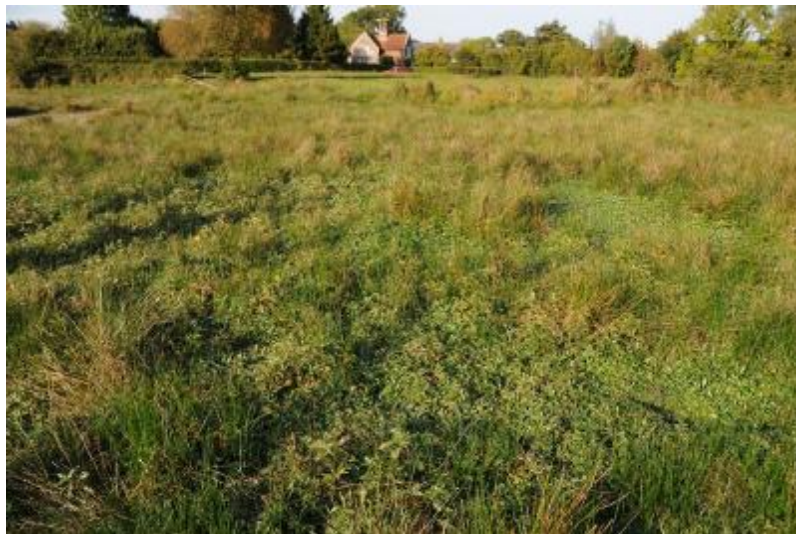
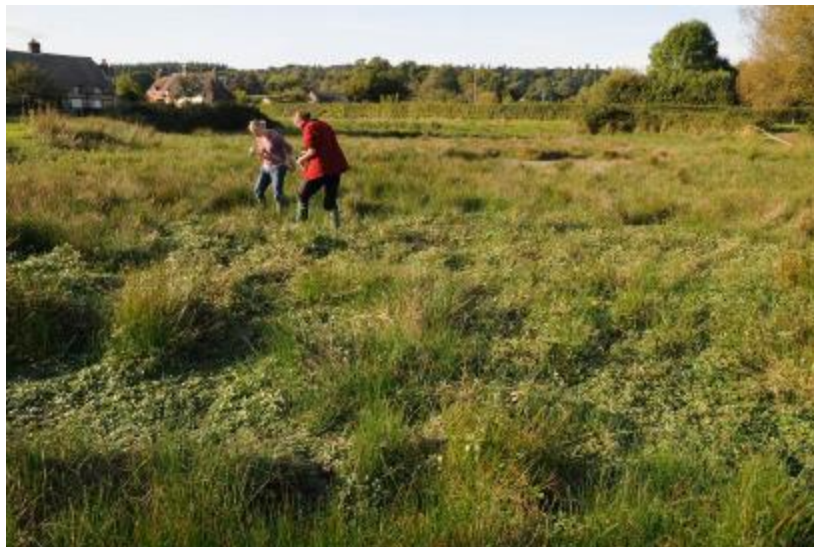
Ludwigia grandiflora at Round Pond, Breamore Marsh on 1 October 2009
(photographs: Trevor Renals)

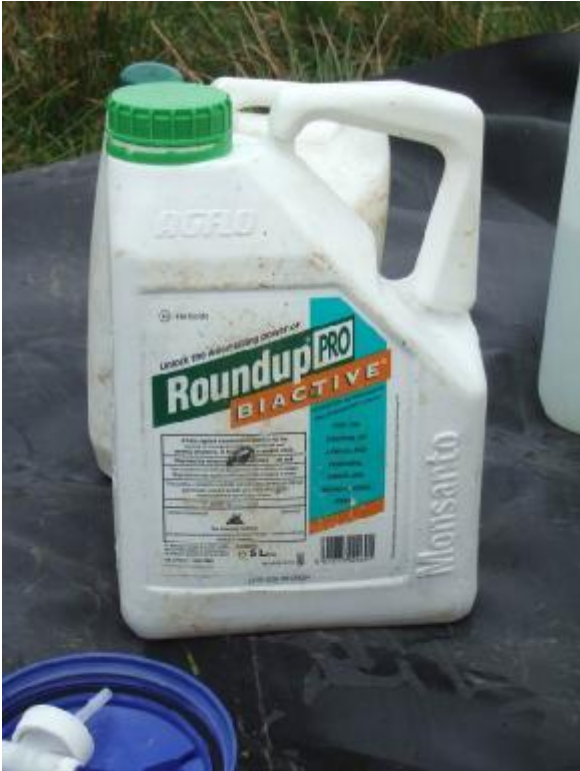
The creeping water primrose at Breamore Marsh was treated with the Glyphosate-based herbicide Roundup Pro Biactive and an adjuvant called 'Topfilm'

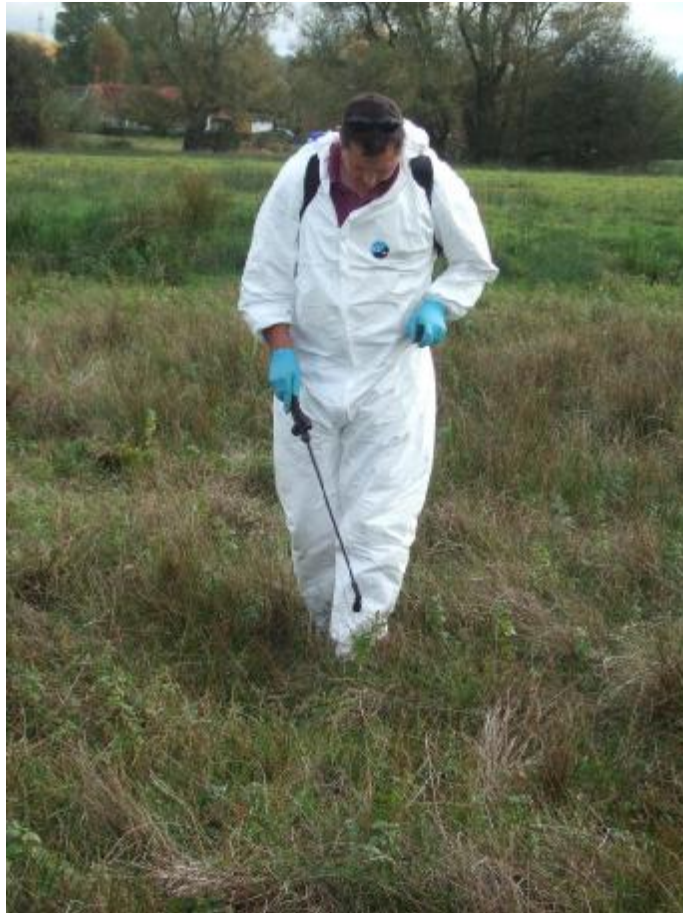
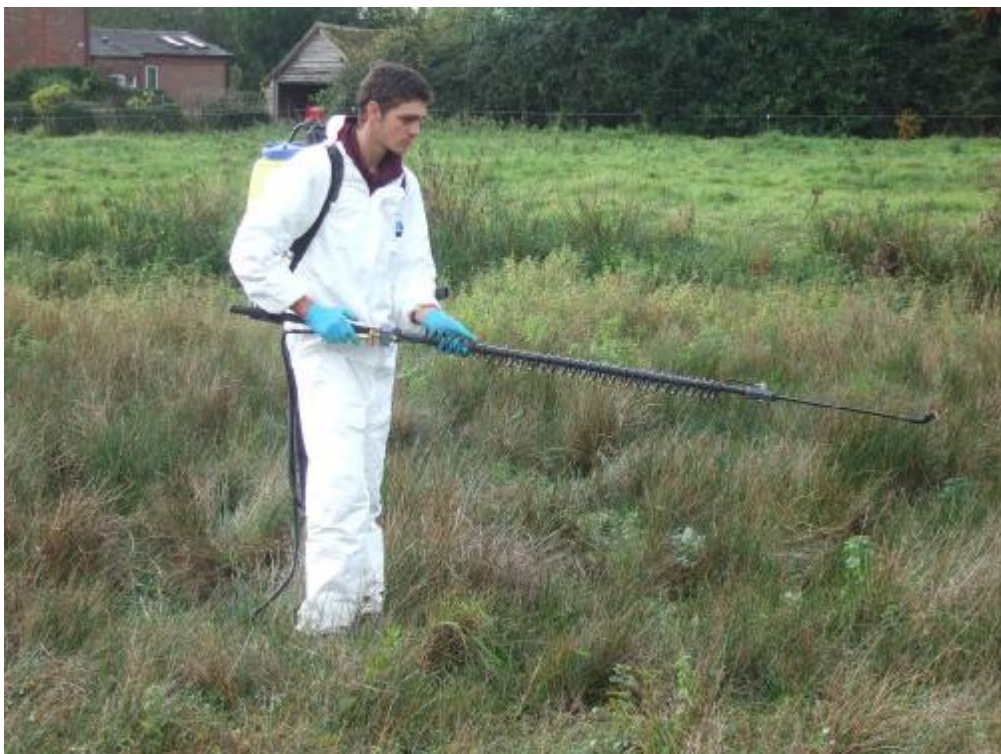
Herbicide treatment being undertaken at Breamore Marsh on 29 October 2009

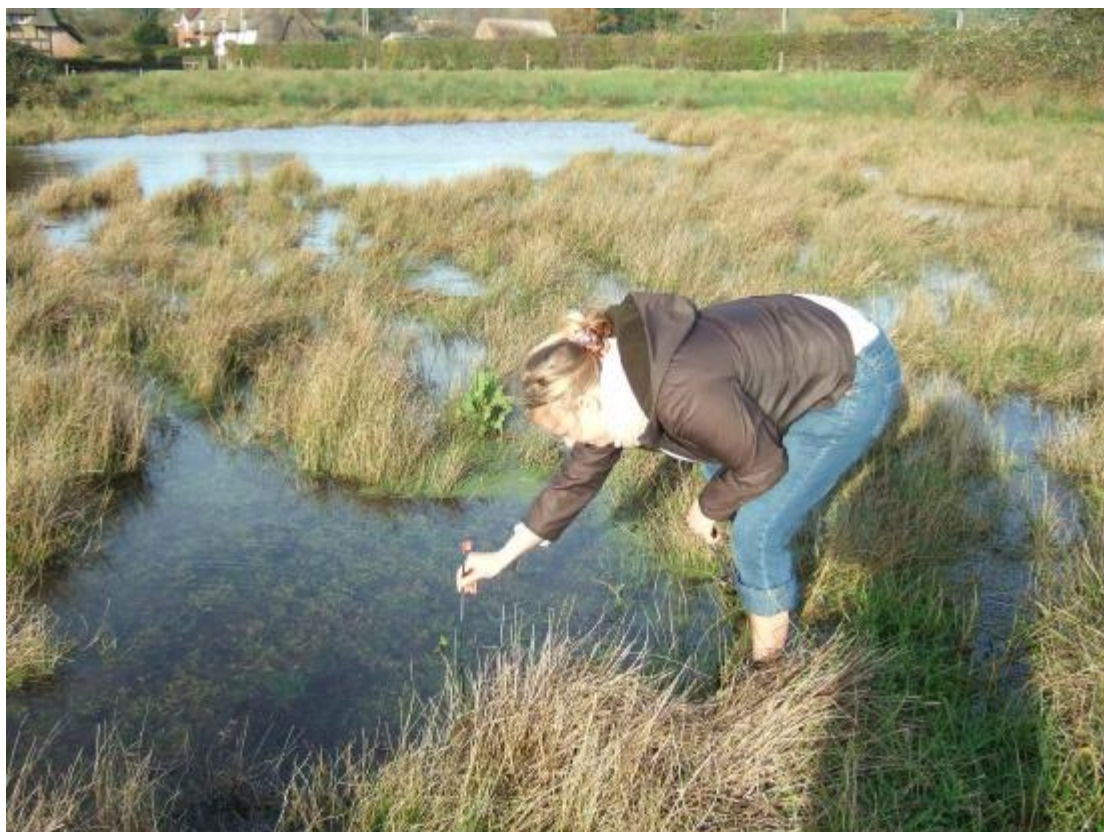
On 19 November 2009 the New Forest Non-Native Plants Officer and a representative of Plantlife visited Round Pond to mark out the creeping water primrose which required further herbicide treatment. 'Flags' made from red adhesive tape were attached to the top of garden canes to mark out areas where further herbicide treatment was necessary. Although some patches of creeping water primrose had clearly been affected by the herbicide treatment, there was evidence of fresh, new growth from many of these patches.

Sophie Thomas of Plantlife at Breamore Marsh on 19 November 2009 marking out areas where more herbicide treatment is required

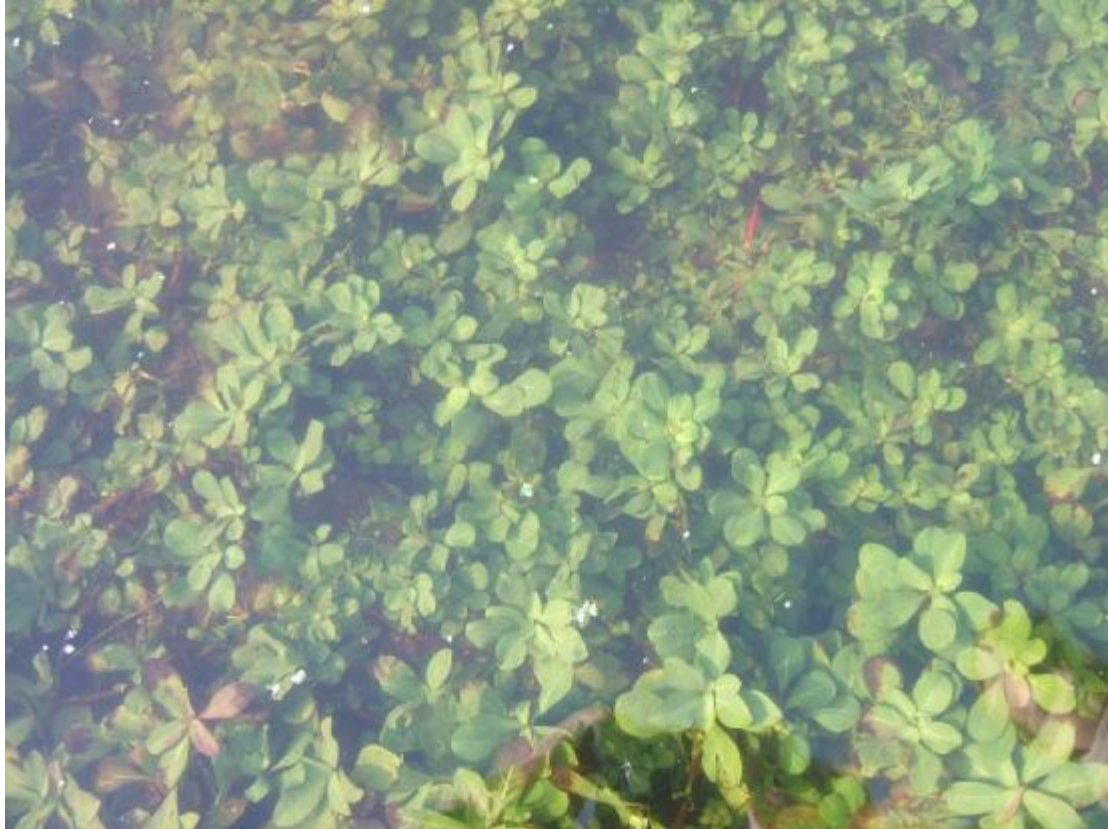
Although there was no rain for the 24 hour period immediately following the herbicide treatment undertaken on 29 October 2009, there had since been a lot of rain so areas which were bare mud or terrestrial vegetation at the time of the herbicide treatment were under water on 19 November 2009. By 19 November 2009 the vast majority of the creeping water primrose was submerged.

Creeping water primrose *Ludwigia grandiflora* leaves submerged on 19 November 2009

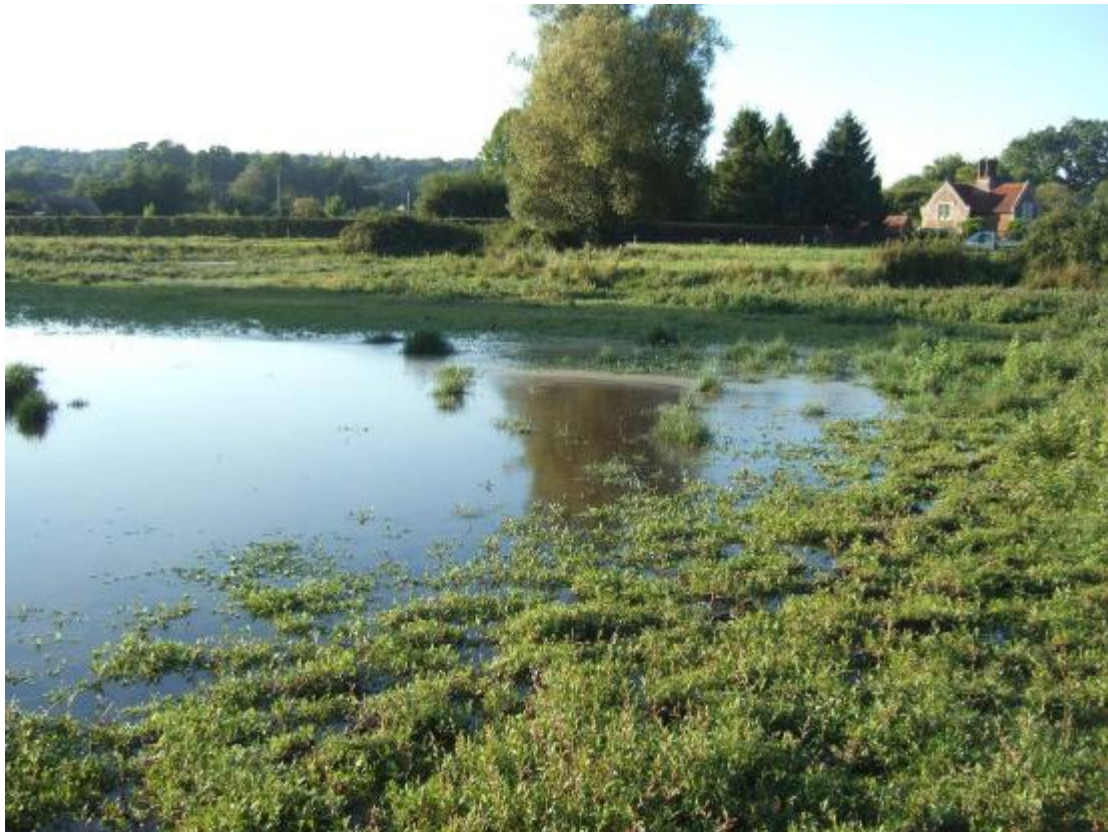
On 18 August 2011 torrential rain was experienced in Hampshire and when Clive Chatters visited Breamore Marsh on 19 August, in the hope of undertaking his annual survey of *Cyperus fuscus*, the water levels were far too high for herbicide treatment to be undertaken and he considered that 'a rather brutal approach' would be needed to control the *Ludwigia* in Round Pond and prevent its spread.

Torrential rain fell in Hampshire on 18 August 2011. When this photograph was taken on 19 August 2011, water levels in Round Pond were uncharacteristically high for this time of the year.

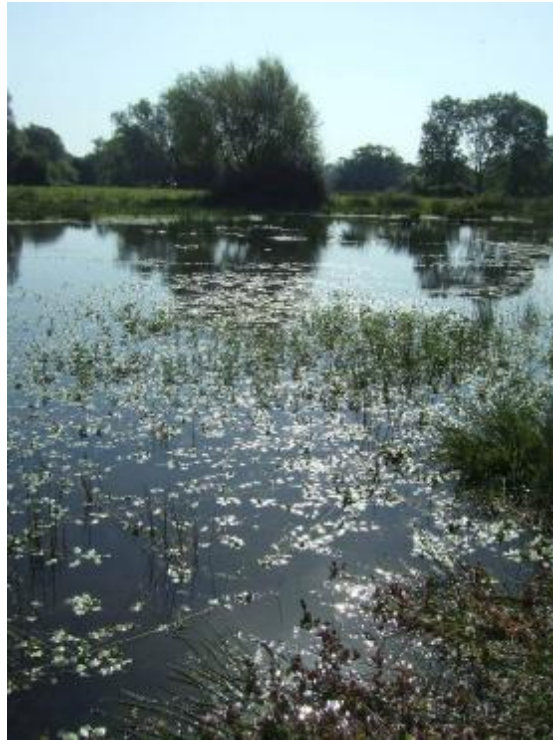
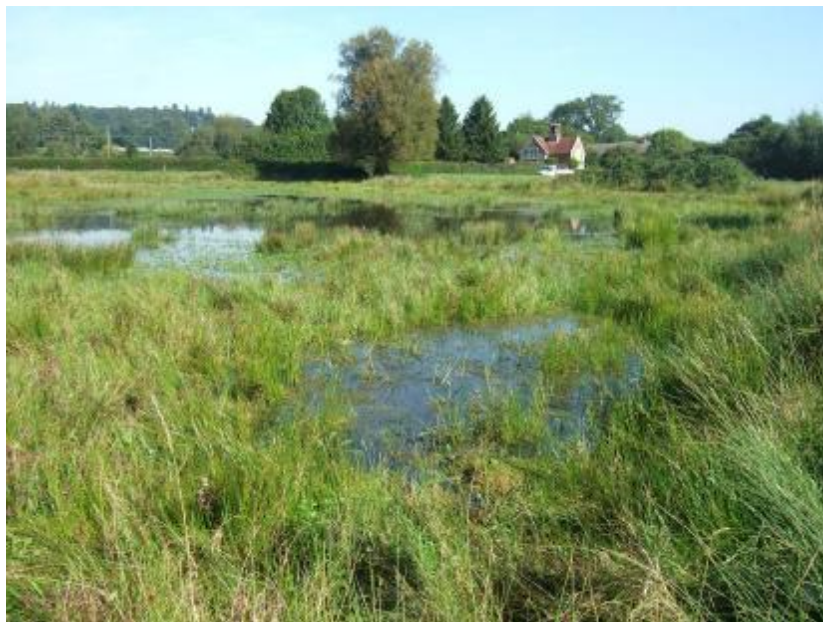
Round Pond on 9 September 2012. Water levels remained too high for herbicide treatment to be undertaken during 2012.

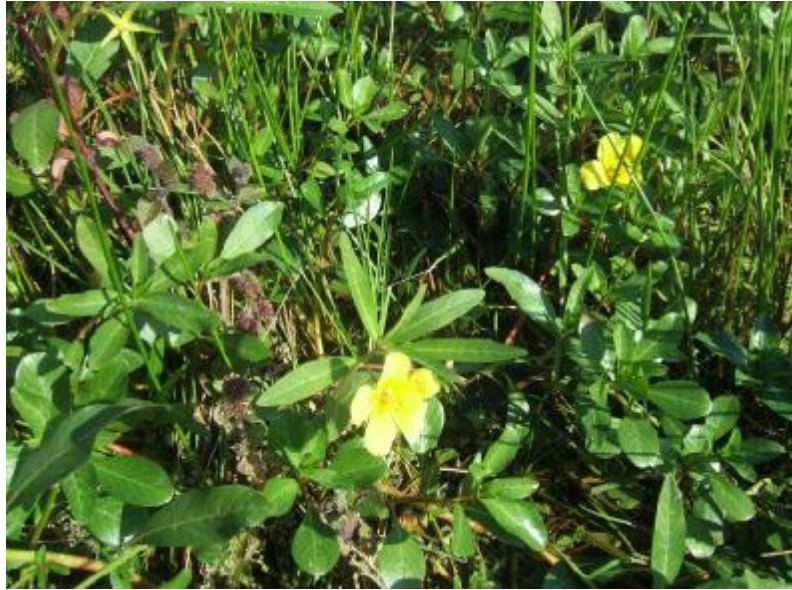
Further herbicide treatments, combined with hand-pulling, were planned for 2012. However, during summer and autumn 2012 Hampshire experienced very high rainfall and consequently the water level in Round Pond was too high for any herbicide treatment to be undertaken that year. The following photographs, taken at Breamore Marsh on 9 September 2012, indicate the height of the water and the growth of the *Ludwigia*.

The high water levels in Round Pond during 2012 prevented any herbicide treatment being undertaken that year and allowed the *Ludwigia grandiflora* to grow profusely as shown in this photograph taken on 9 September 2012

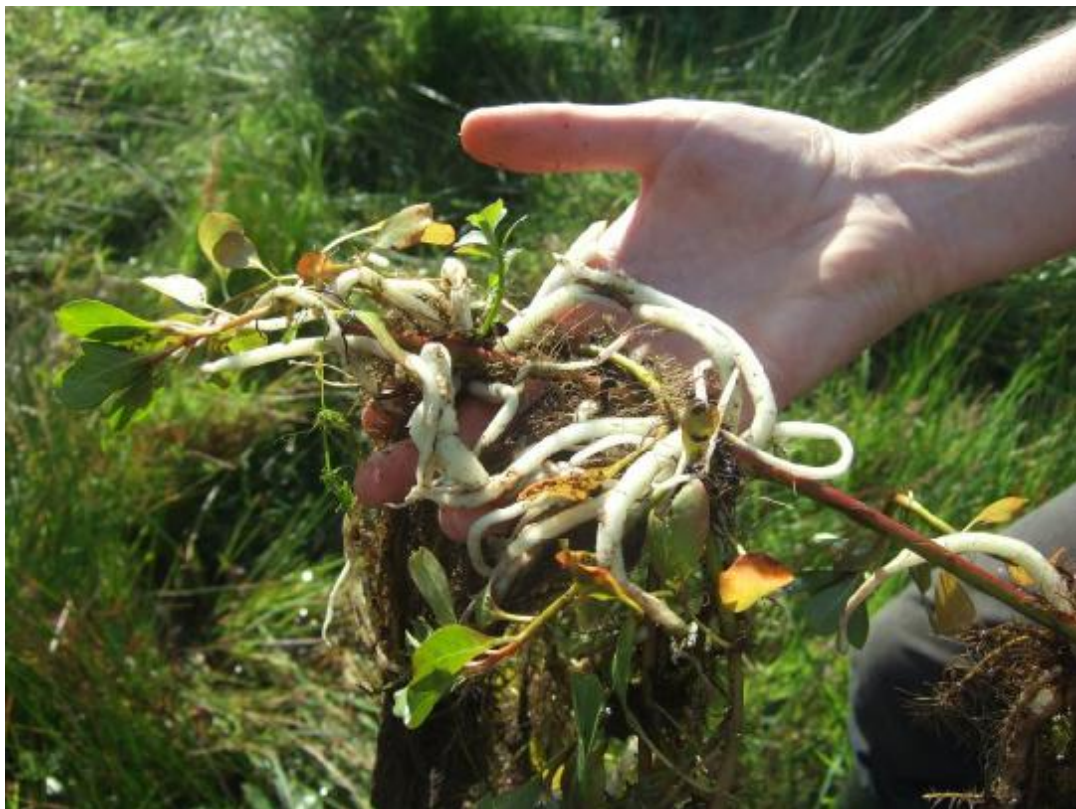
Photograph taken on 9 September 2012 showing a) the white, porous upward-growing aerenchymous roots (pneumatophores) which provide a conduit for atmospheric gases to be transferred throughout the plant in anaerobic conditions and b) the downward-growing adventitious roots (arising from the stem) which absorb nutrients in the water column, often without contact with the substrate.
