# **Control of the Invasive Non-Native Creeping Water Primrose at Breamore Marsh, Hampshire**

Report relating to the first ten years 2009 - 2019

**Catherine Chatters and Joanne Gore**  
**New Forest Non-Native Plants Project**  
December 2019

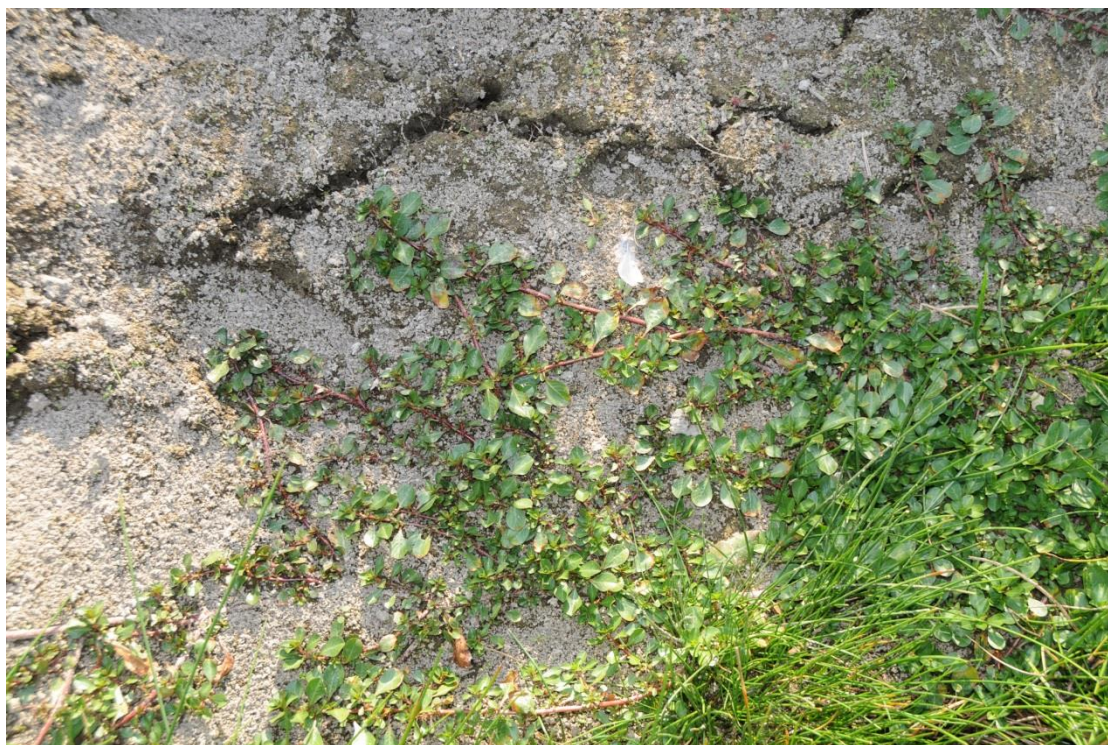
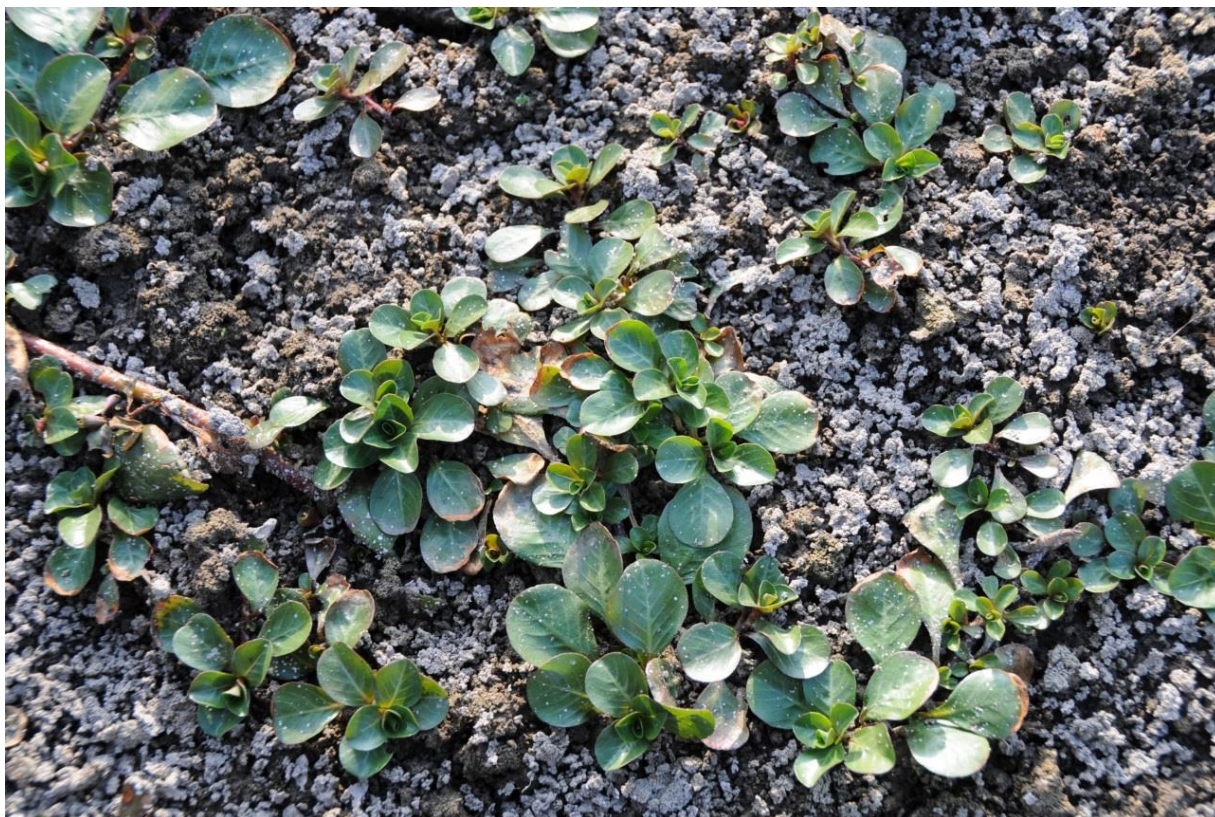
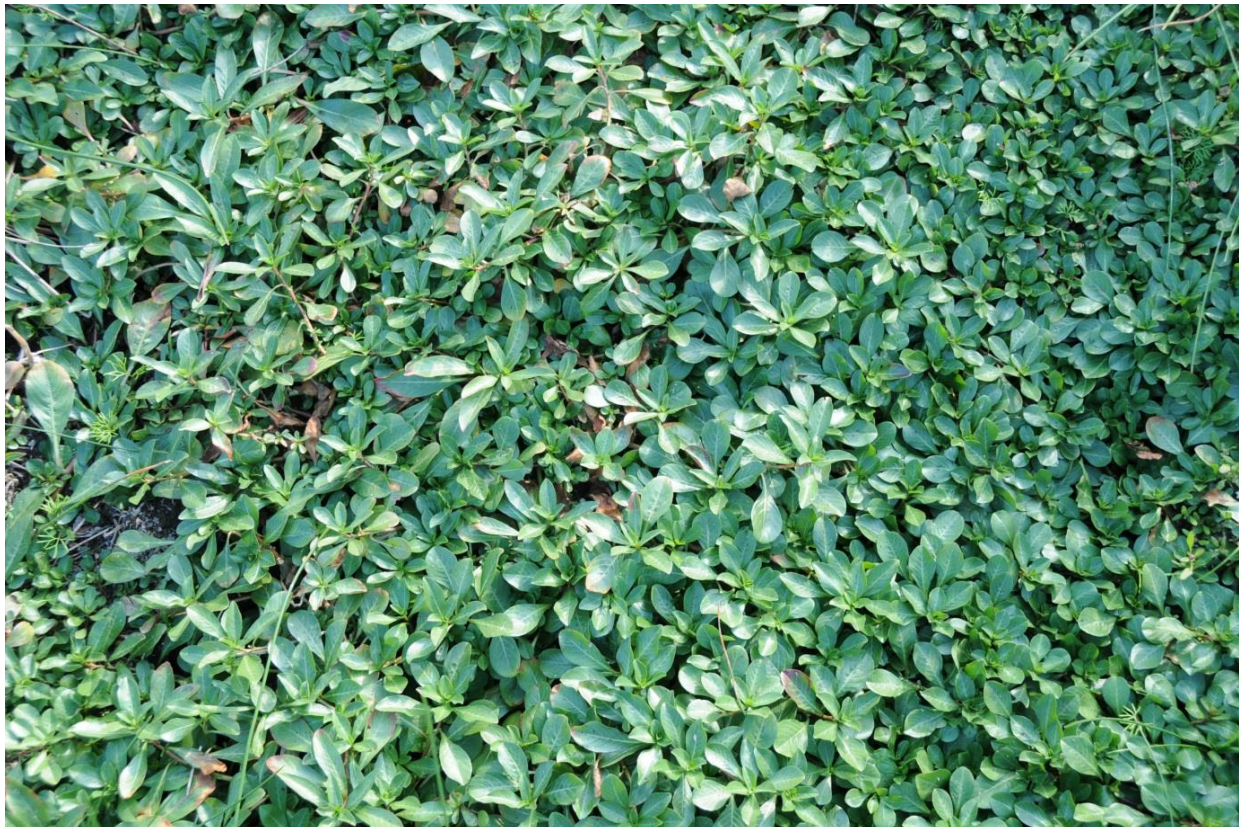
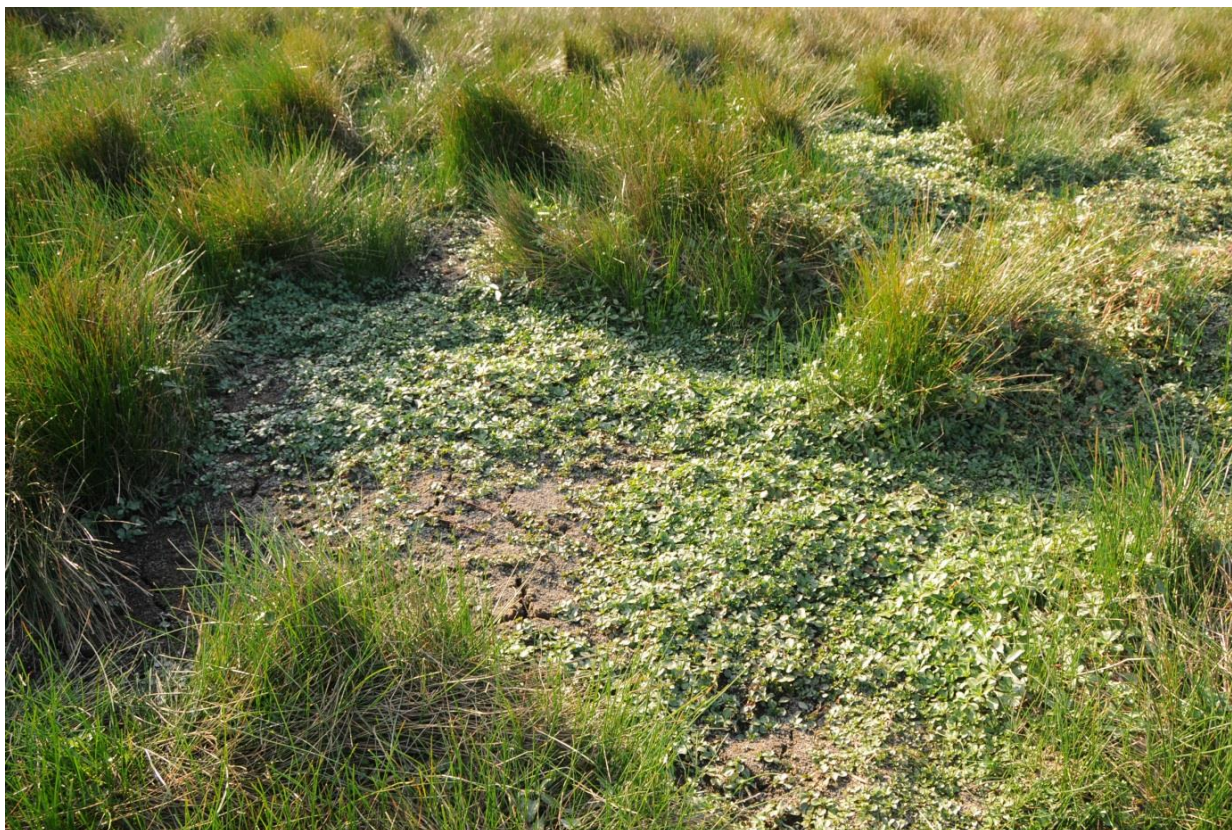
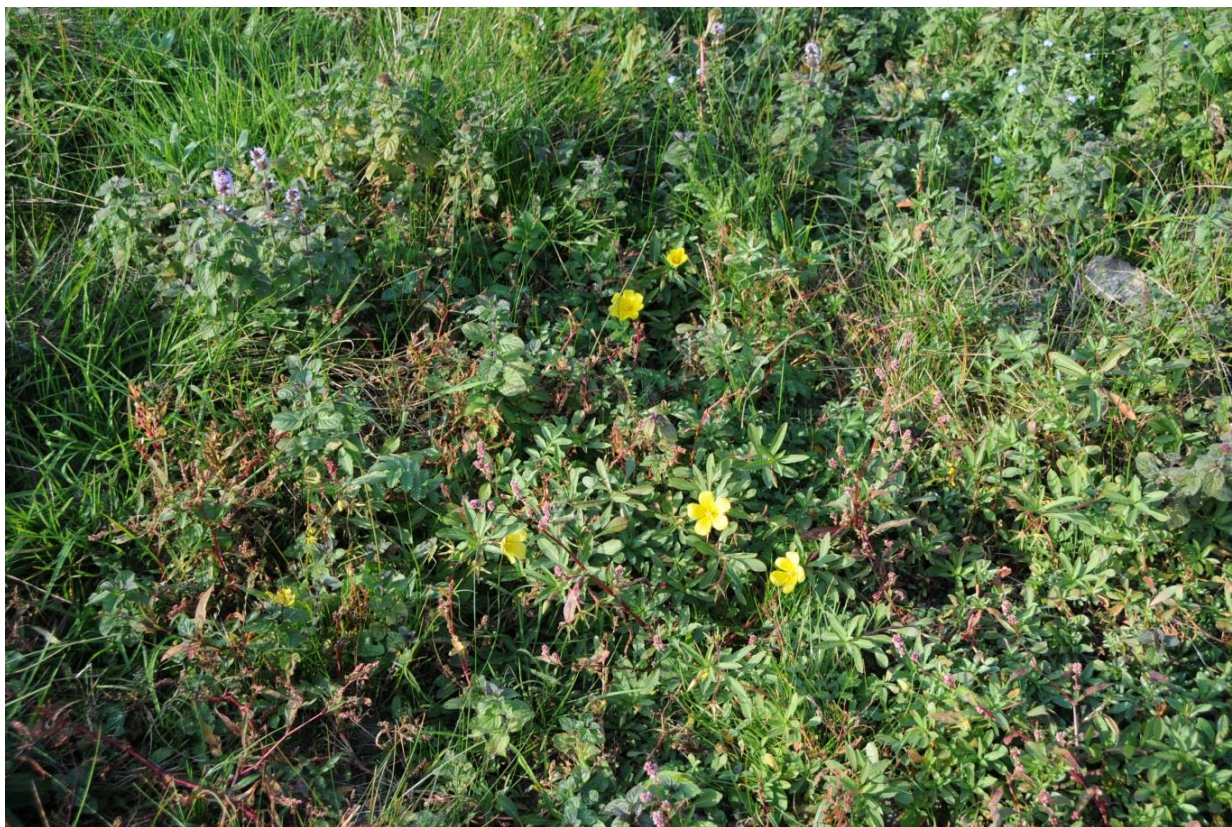
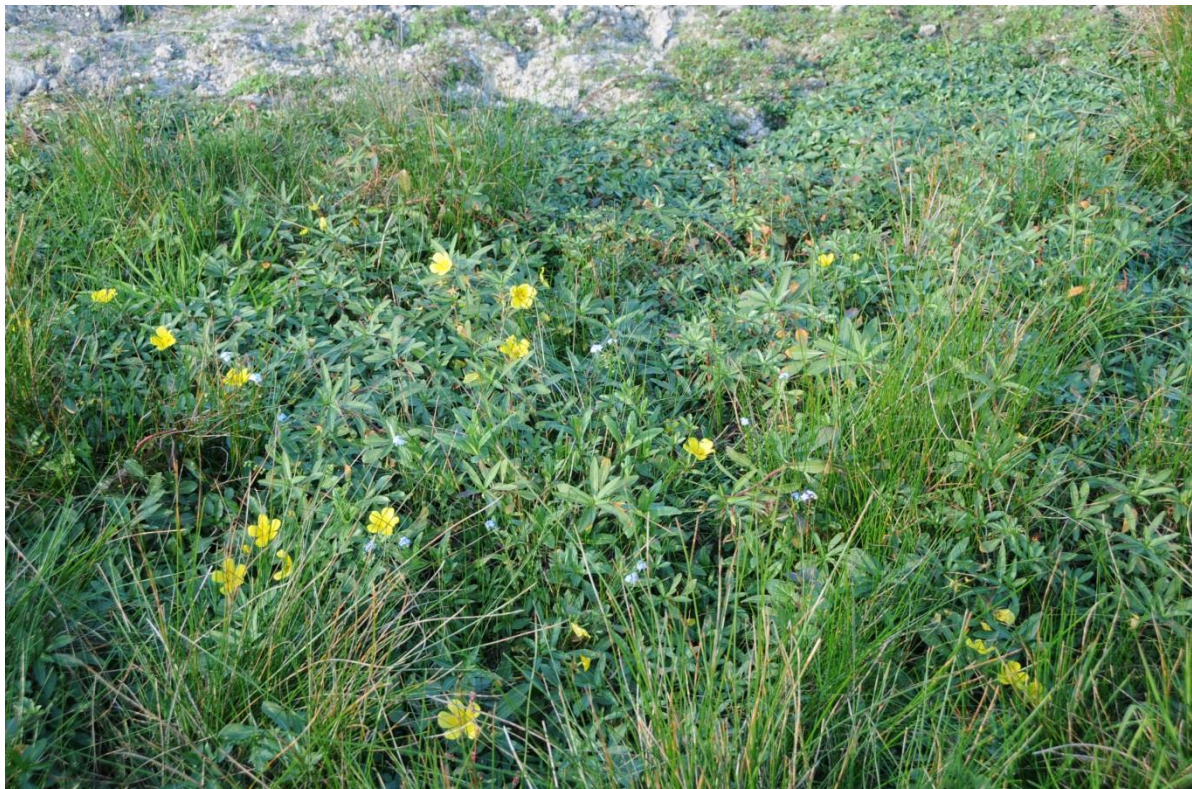
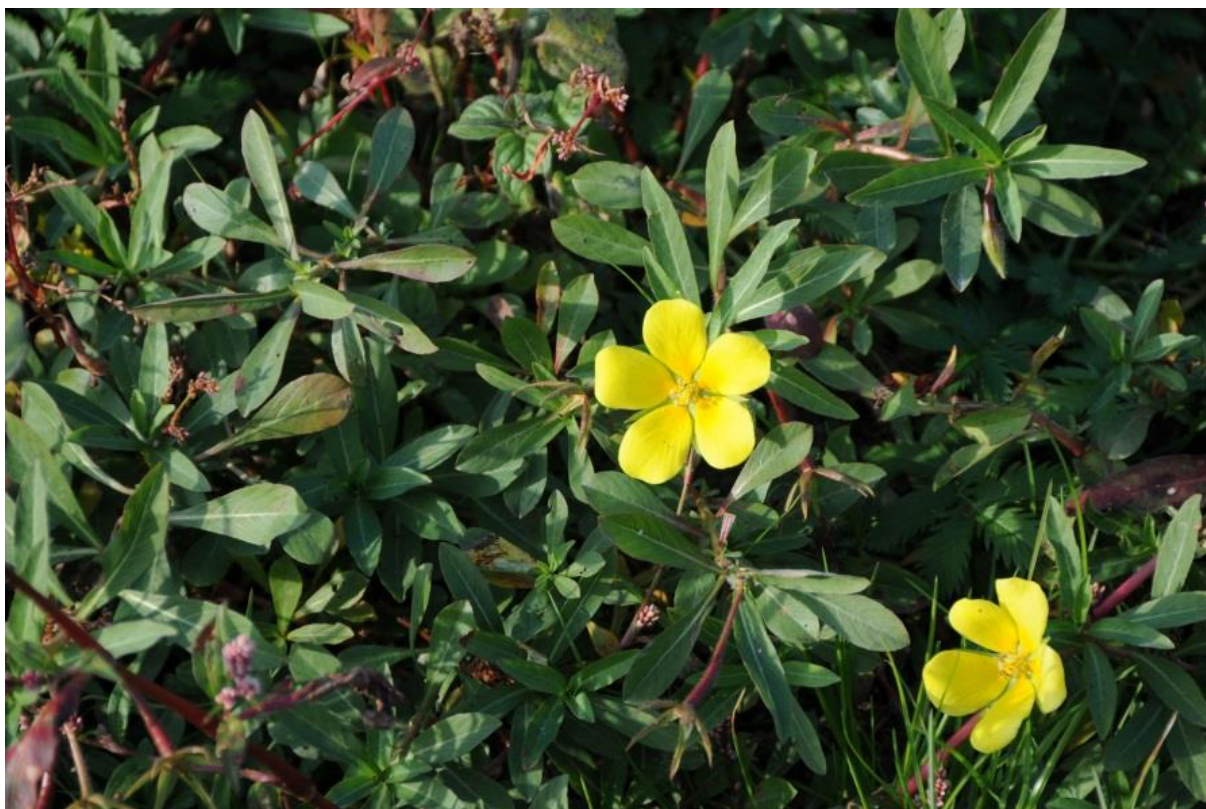
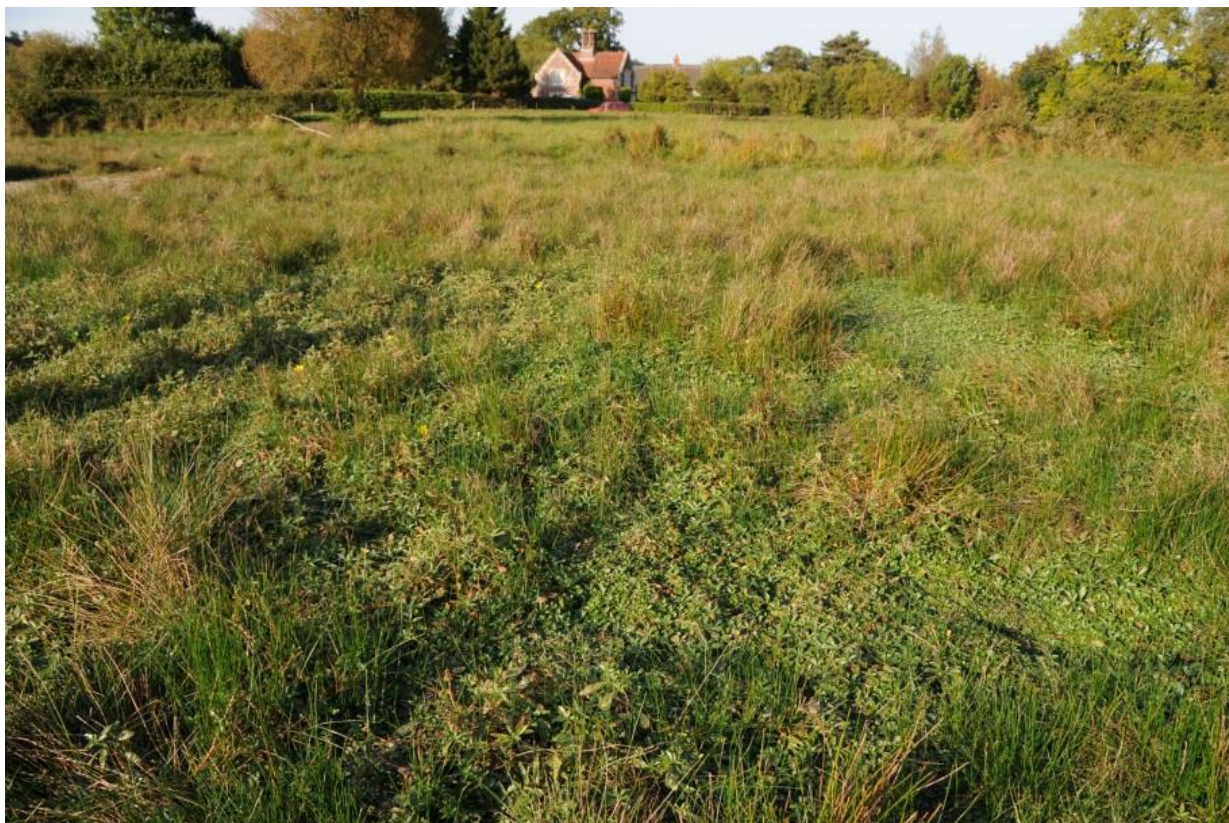
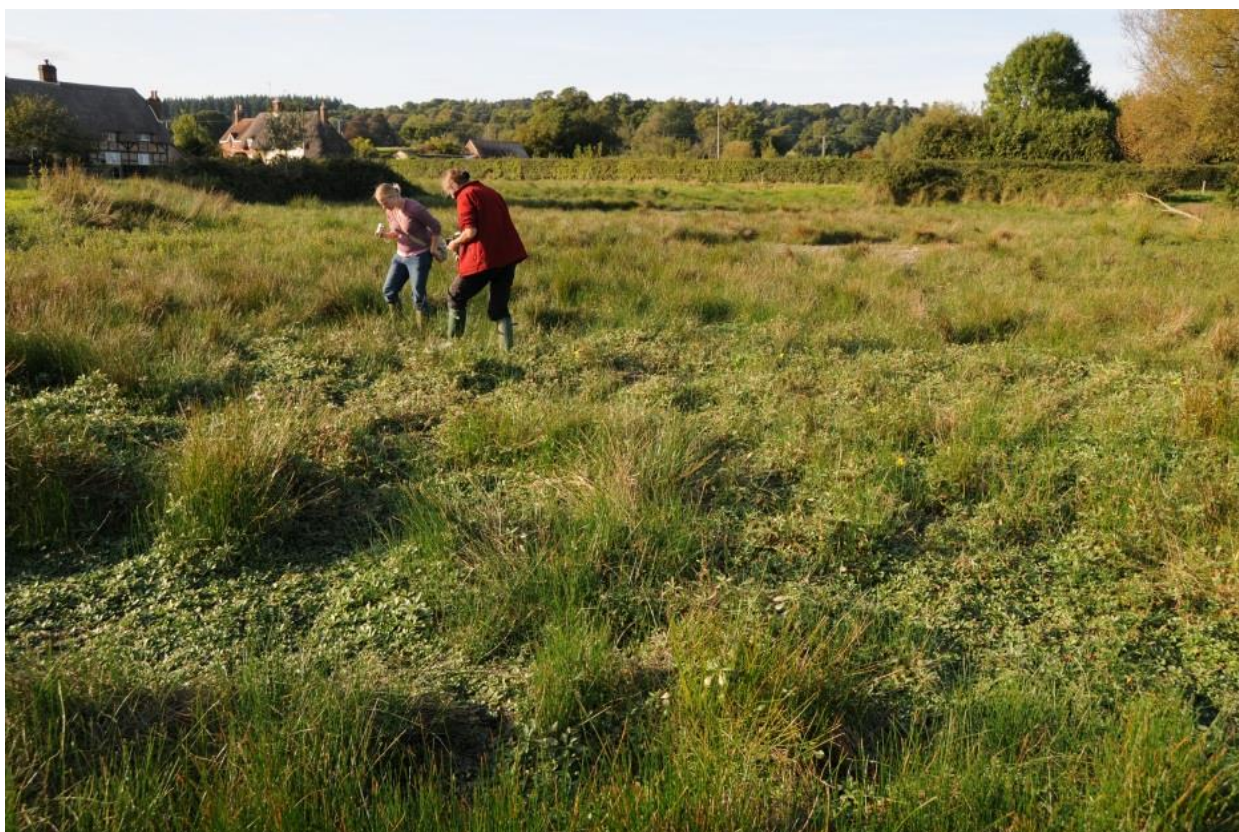
The creeping water primrose was dominant over large parts of Round Pond, spreading across bare mud, forming dense mats of foliage and flowering amongst other vegetation (Figure 9, Figure 10, Figure 11, Figure 12, Figure 13, Figure 14, Figure 15, Figure 16 and Figure 17).

**Figure 9:** Creeping water primrose photographed at Round Pond on 1 October 2009 (photograph: Trevor Renals)

**Figure 10:** Creeping water primrose photographed at Round Pond on 1 October 2009  
(Photograph: Trevor Renals)

**Figure 11:** Creeping water primrose photographed at Round Pond on 1 October 2009  
(Photograph: Trevor Renals)

**Figure 12:** Creeping water primrose photographed at Round Pond on 1 October 2009  
(Photograph: Trevor Renals)

**Figure 13:** Creeping water primrose photographed at Round Pond on 1 October 2009  
(Photograph: Trevor Renals)

**Figure 14:** Creeping water primrose photographed at Round Pond on 1 October 2009  
(Photograph: Trevor Renals)

**Figure 15:** Creeping water primrose photographed at Round Pond on 1 October 2009  
(Photograph: Trevor Renals)

**Figure 16:** Creeping water primrose photographed at Round Pond on 1 October 2009  
(Photograph: Trevor Renals)

**Figure 17:** Creeping water primrose photographed at Round Pond on 1 October 2009  
(Photograph: Trevor Renals)

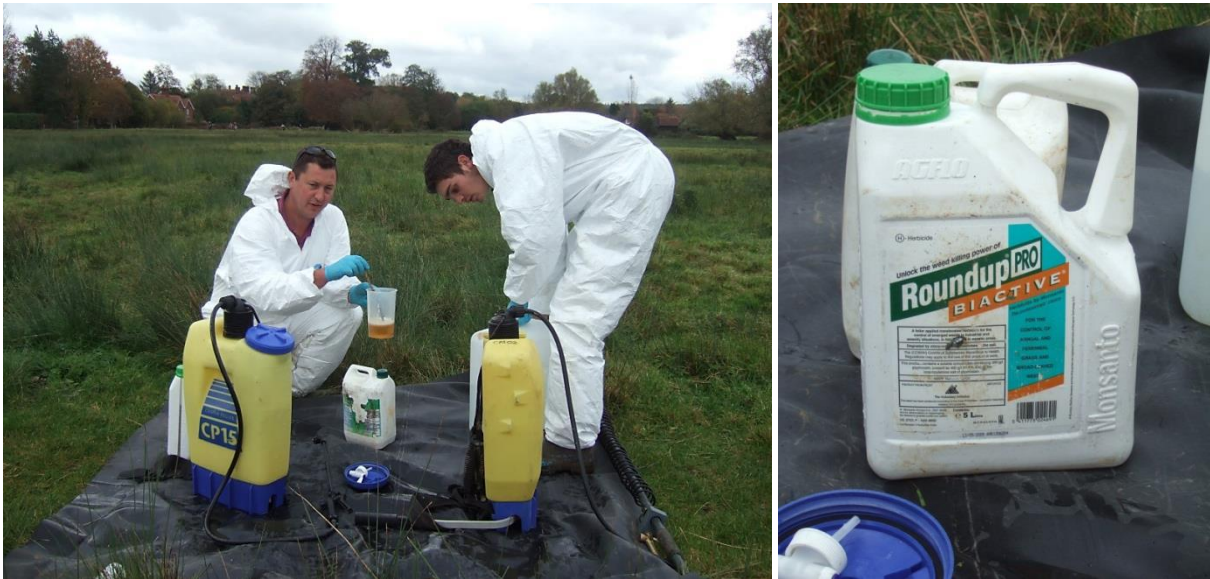
**Figure 18:** Scott Rice and George Hyde of Kingcombe Aquacare Ltd preparing the herbicide for treatment of creeping water primrose at Breamore Marsh SSSI on 29 October 2009. The creeping water primrose was treated with the Glyphosate-based herbicide Roundup Pro Biactive and an adjuvant called 'Topfilm'

Kingcombe Aquacare Ltd planned to undertake the first herbicide treatment on Tuesday 6 October 2009 but unfortunately the weather that day was very wet and the work had to be postponed until 29 October 2009 as herbicide treatment is only effective in dry conditions (Figure 18, Figure 19).

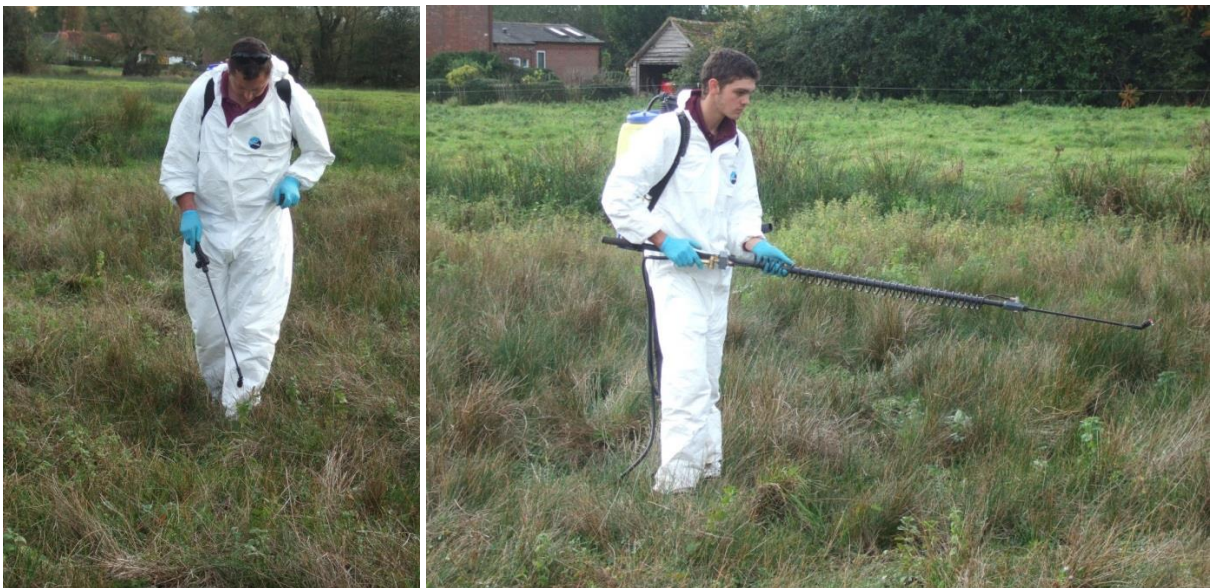
**Figure 19:** Herbicide treatment being undertaken at Breamore Marsh on 29 October 2009

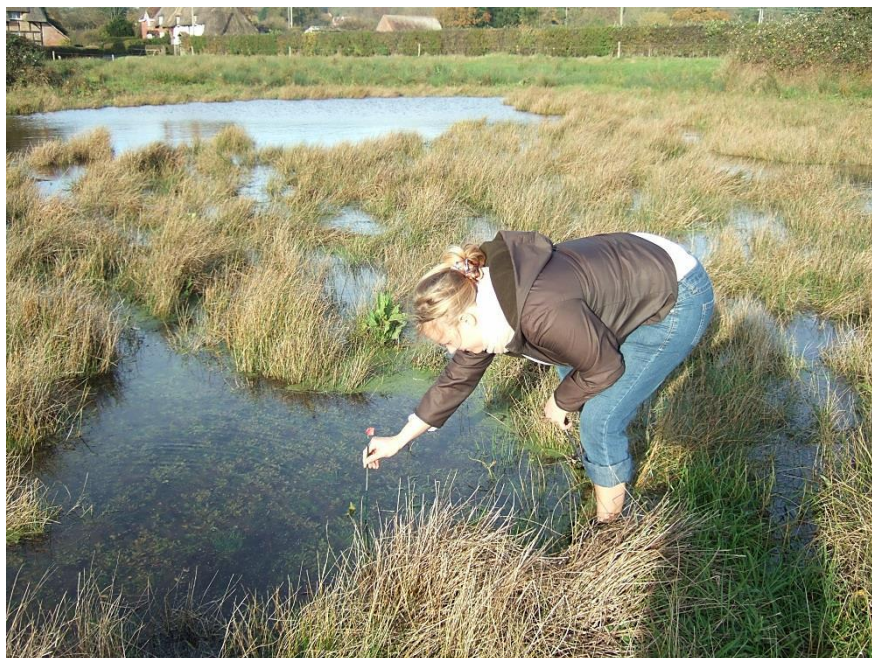
**Figure 20:** Sophie Thomas of Plantlife at Breamore Marsh on 19 November 2009 marking out areas where more herbicide treatment is required

On 19 November 2009 the New Forest Non-Native Plants Officer and a representative of Plantlife visited Round Pond to mark out the creeping water primrose which required further herbicide treatment. 'Flags' made from red adhesive tape were attached to the top of garden canes to mark out areas where further herbicide treatment was necessary (Figure 20). Although some patches of creeping water primrose had clearly been affected by the herbicide treatment, there was evidence of fresh, new growth from many of these patches.

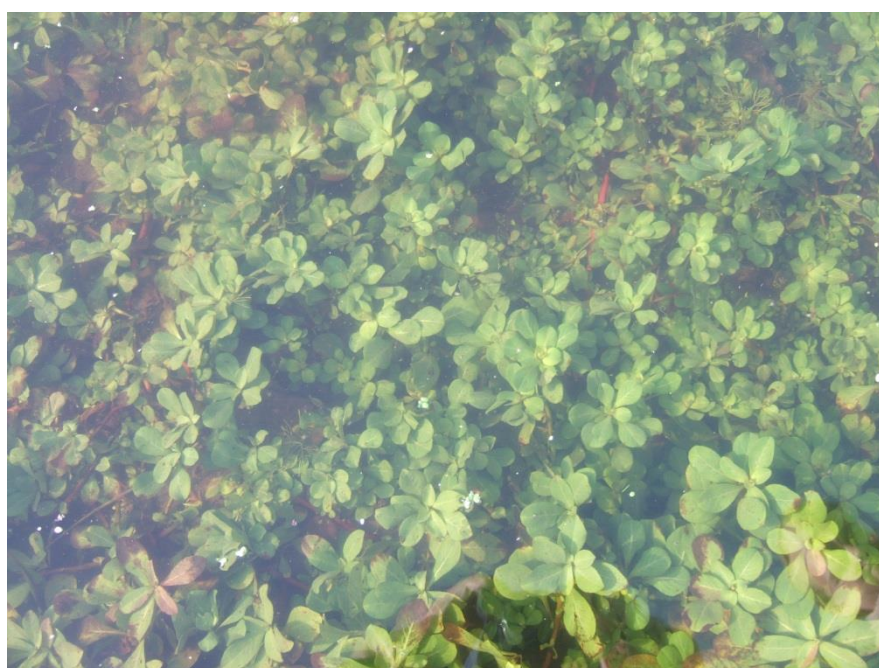
Although there was no rain for the 24 hour period immediately following the herbicide treatment undertaken on 29 October 2009, there had since been a lot of rain so areas which were bare mud or terrestrial vegetation at the time of the herbicide treatment were under water on 19 November 2009. By 19 November 2009 the vast majority of the creeping water primrose was submerged (Figure 21).

**Figure 21:** Creeping water primrose *Ludwigia grandiflora* leaves submerged on 19 November 2009

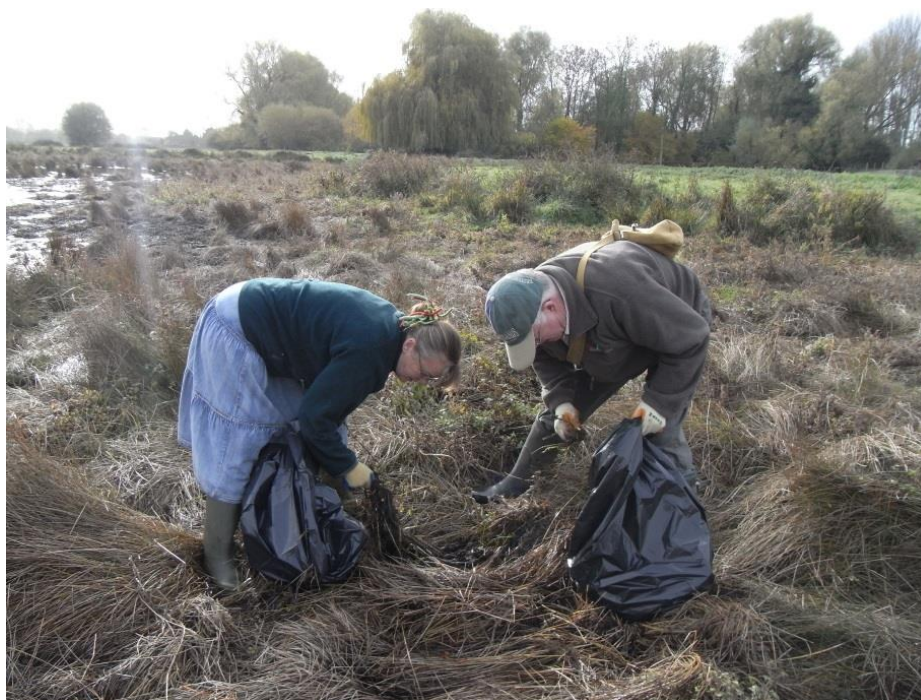
**Figure 22:** Local residents helped the Project Officer hand-pull *Ludwigia grandiflora* at Round Pond on 3 November 2010 (Photograph: Joanne Gore)

A volunteer working party was arranged and led by the Project Officer on 3 November 2010 to hand-pull remaining plants to help raise awareness of the problems caused by this invasive non-native plant (Figure 22). Posters were displayed around Breamore Marsh and leaflets were delivered to a number of nearby houses. Two local residents volunteered to help the Project Officer and in two hours (six 'man-hours') they had filled six refuse sacks. On arrival at the site, the initial impression was that the herbicide treatment had effectively killed all the creeping water primrose but when a dead-looking stem was pulled up and scraped, it was apparent that it was still alive. Some creeping water primrose plants were sprouting where they had disappeared out of view under rushes *Juncus* spp. Effort was focussed on the area near the outlet.

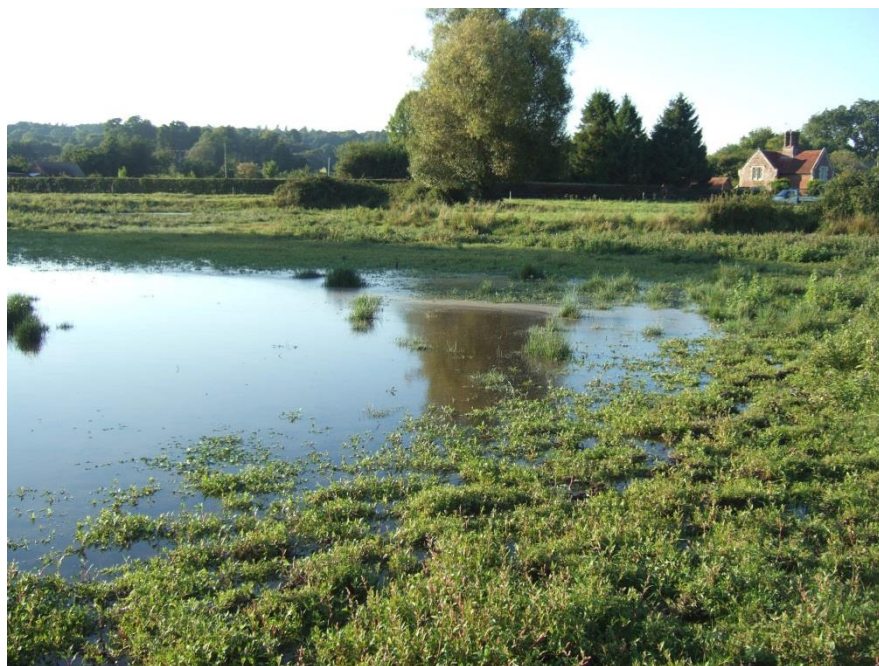
On 18 August 2011 torrential rain was experienced in Hampshire and when Clive Chatters visited Breamore Marsh on 19 August, in the hope of undertaking his annual survey of *Cyperus fuscus*, the water levels were far too high for herbicide treatment to be undertaken and he considered that 'a rather brutal approach' would be needed to control the creeping water primrose in Round Pond and prevent its spread. (Figure 23)

**Figure 23:** Torrential rain fell in Hampshire on 18 August 2011. When this photograph was taken on 19 August 2011 water levels in Round Pond were uncharacteristically high for this time of the year.

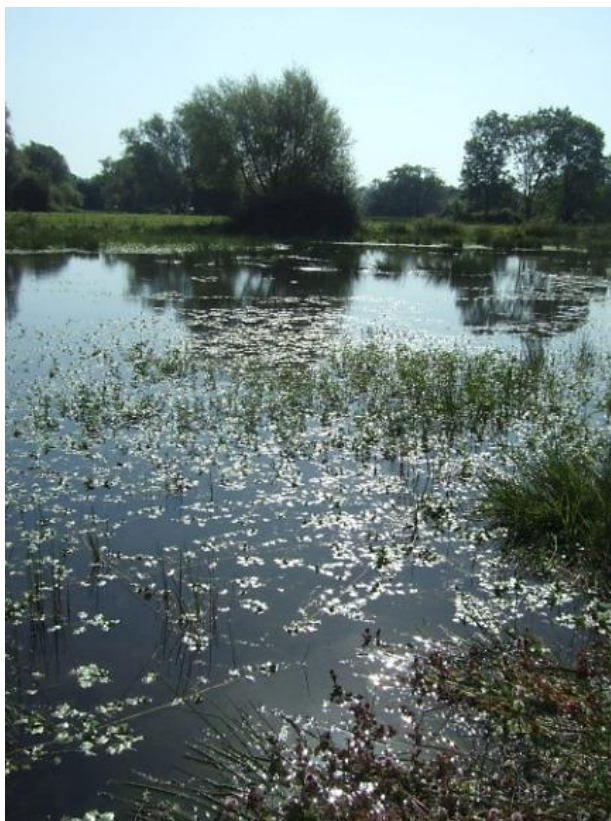
**Figure 24:** Round Pond on 9 September 2012.

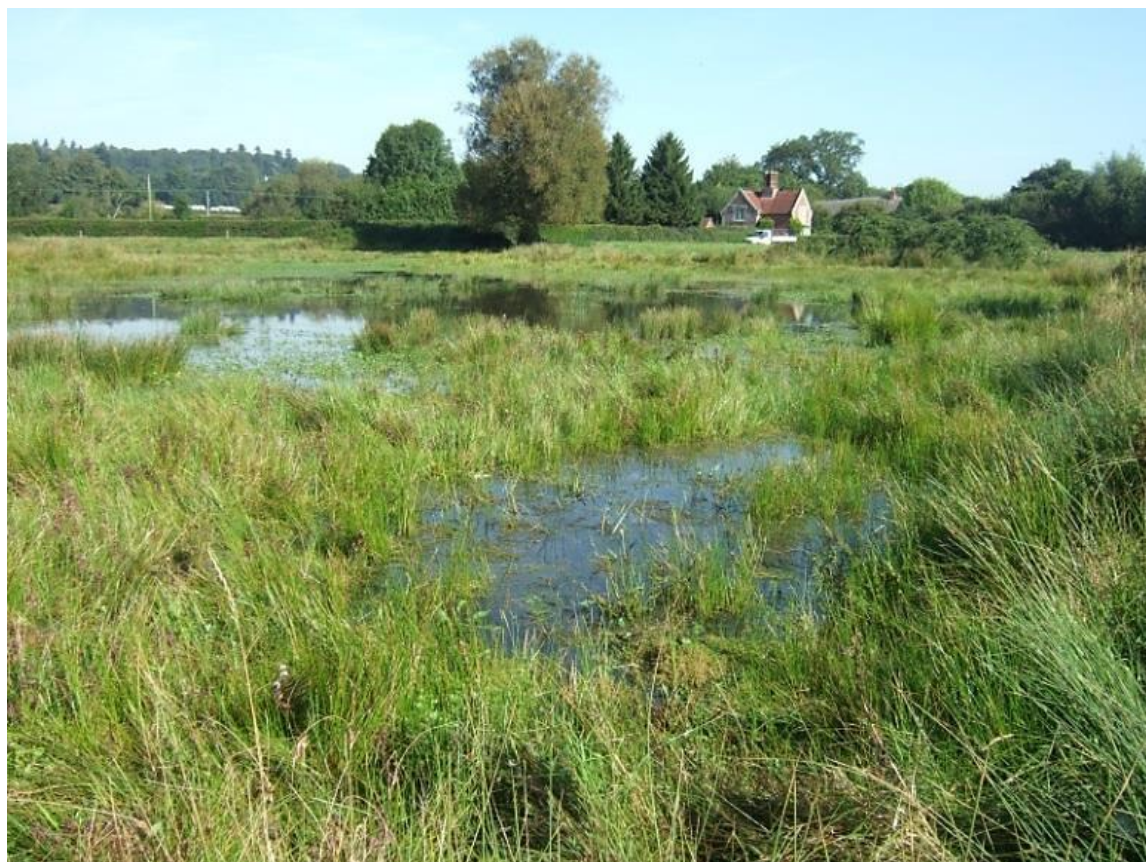
Herbicide treatments, combined with hand-pulling, were planned for 2012. However, during summer and autumn 2012 Hampshire experienced very high rainfall and consequently the water level in Round Pond was too high for any herbicide treatment to be undertaken that year. The following photographs, taken at Breamore Marsh on 9 September 2012, indicate the height of the water and the growth of the creeping water primrose (Figure 24 and Figure 25).

**Figure 25:** Round Pond on 9 September 2012. Water levels remained too high for herbicide treatment to be undertaken during 2012.

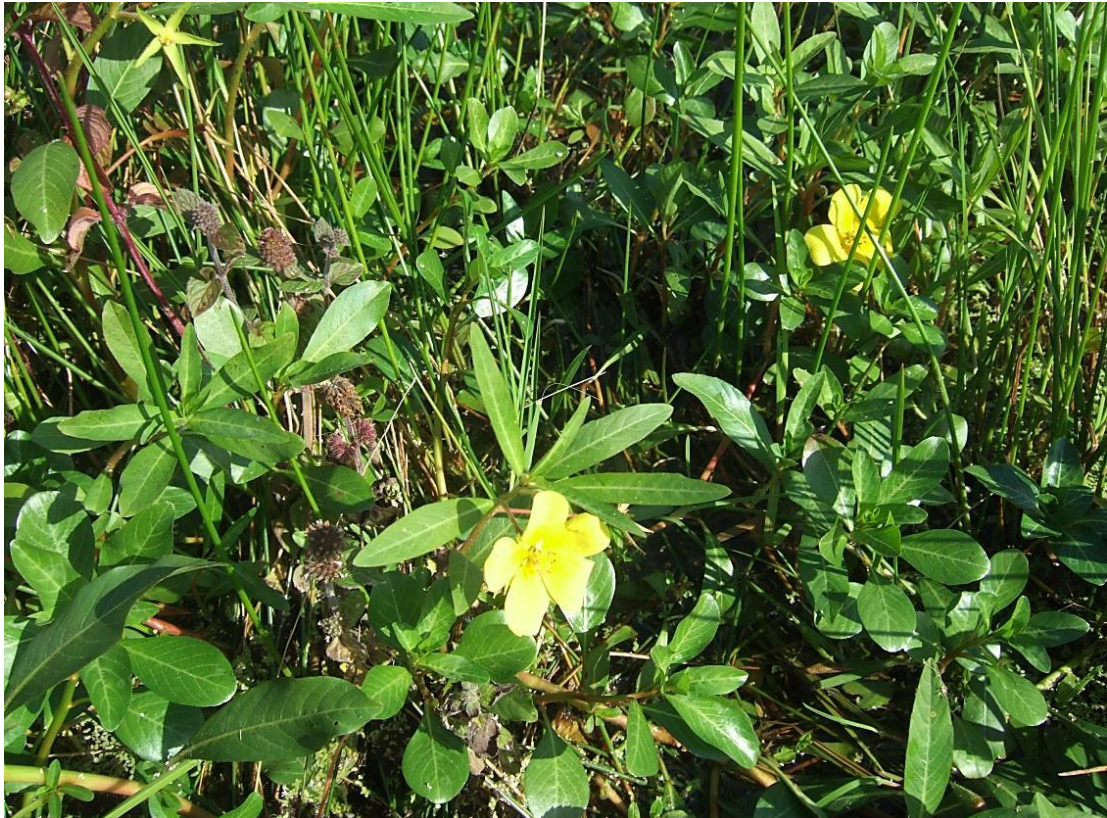
The lack of herbicide treatment during 2012 allowed the creeping water primrose to grow profusely (Figure 26)

**Figure 26:** profuse growth of creeping water primrose photographed on 9 September 2012

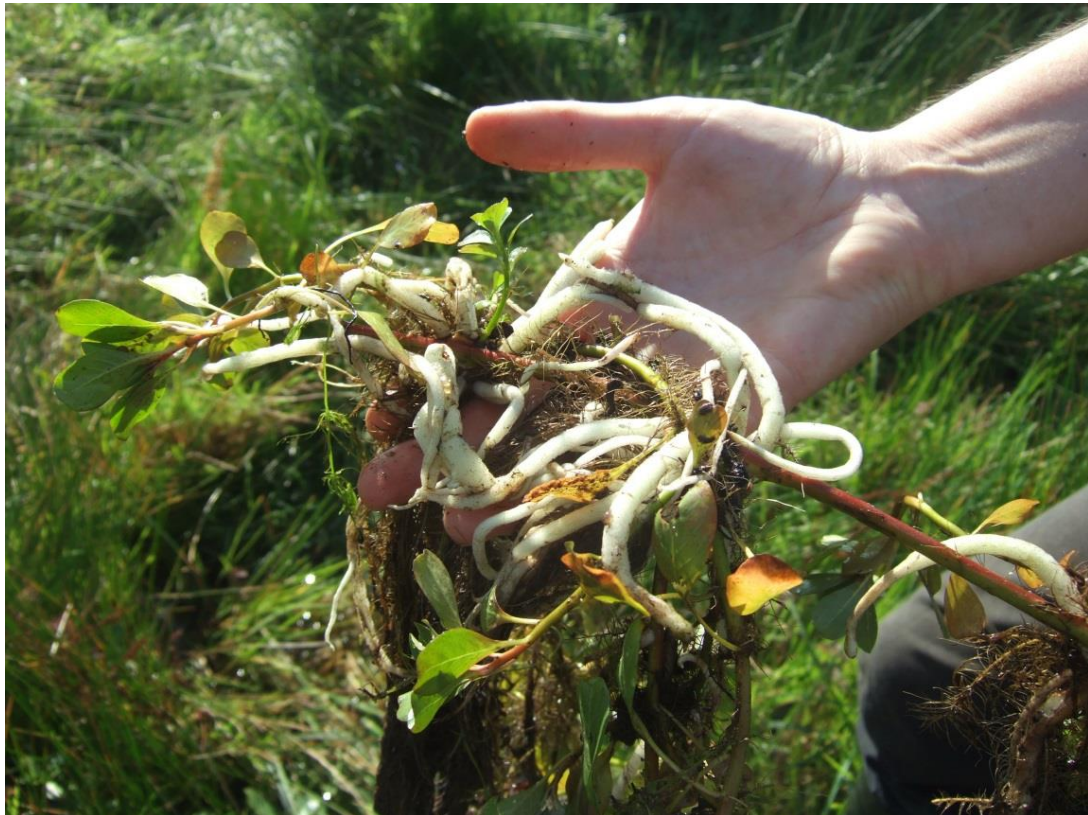
During 2012 the creeping water primrose plants in Round Pond developed pneumatophores which provide a conduit for atmospheric gases to be transferred throughout the plant in anaerobic conditions (Figure 27).

**Figure 27:** Photograph taken on 9 September 2012 showing a) the white, porous upward-growing aerenchymous roots (pneumatophores) and b) the downward-growing adventitious roots (arising from the stem) which absorb nutrients in the water column, often without contact with the substrate.

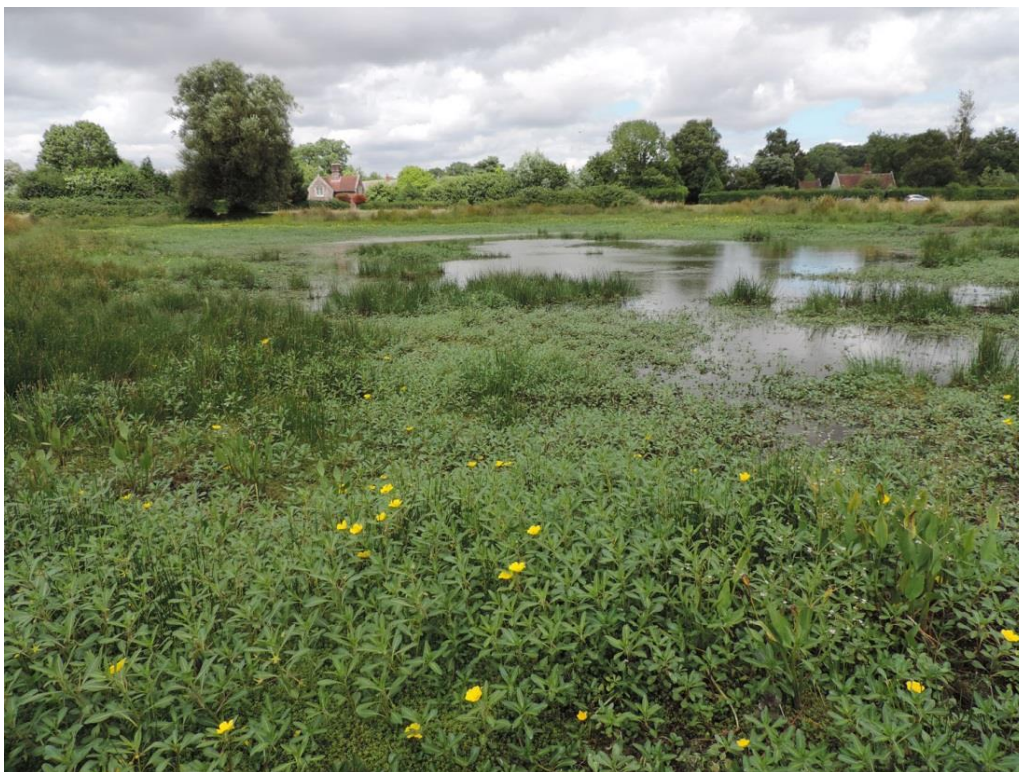
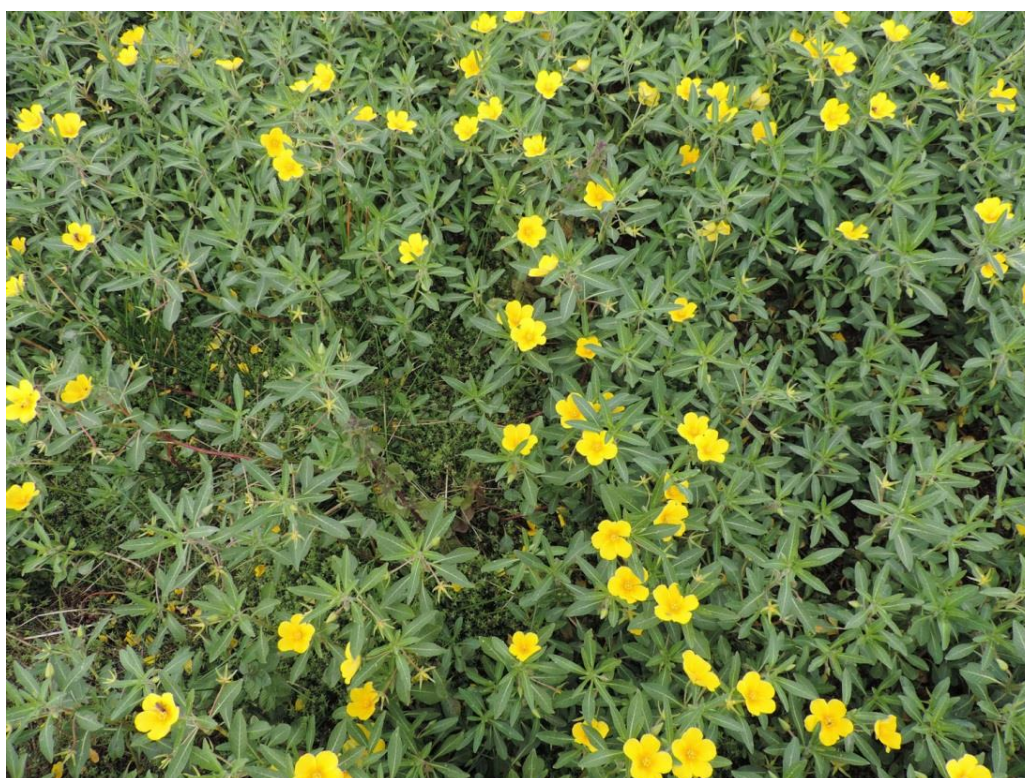
**Figure 29:** Round Pond photographed during July 2013 showing vegetation dominated by creeping water primrose and New Zealand pygmyweed that had displaced mud annual communities. (Photograph: Neil Sanderson)

**Figure 30:** Creeping water primrose in Round Pond during July 2013 (Photograph: Neil Sanderson)

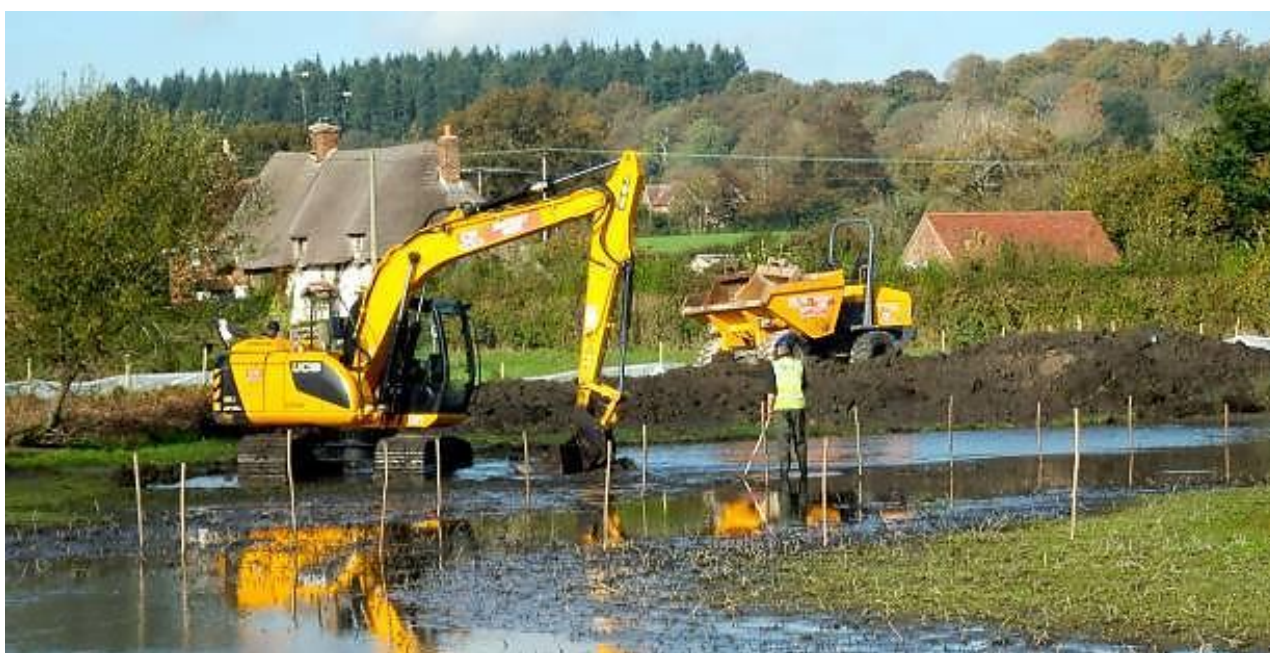
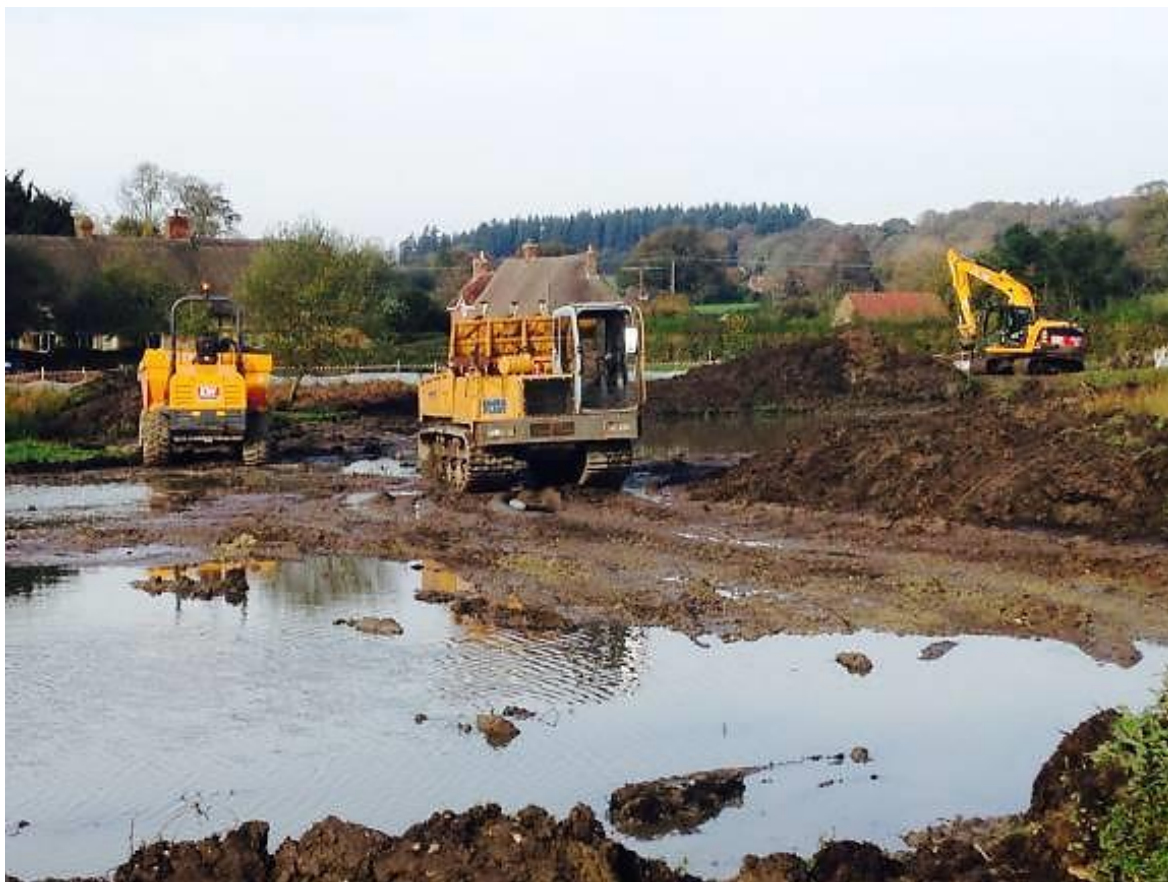
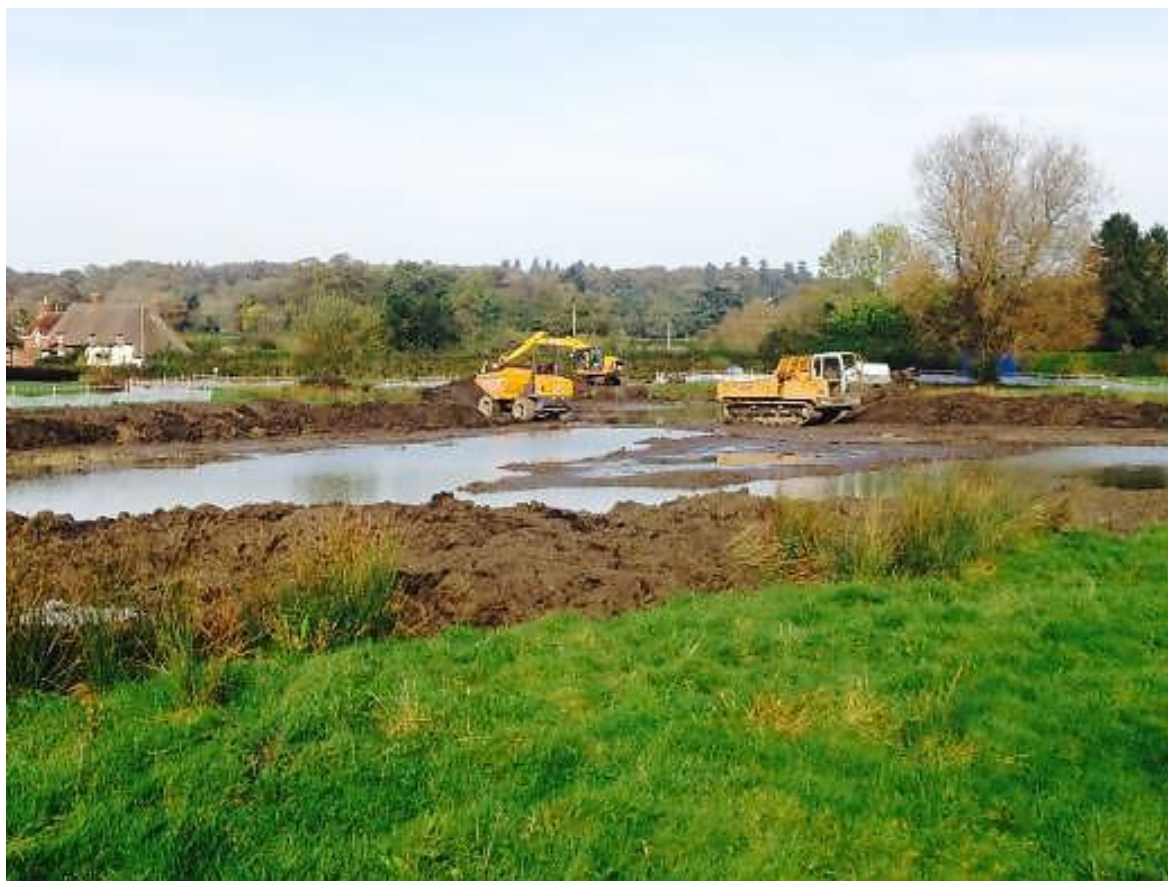
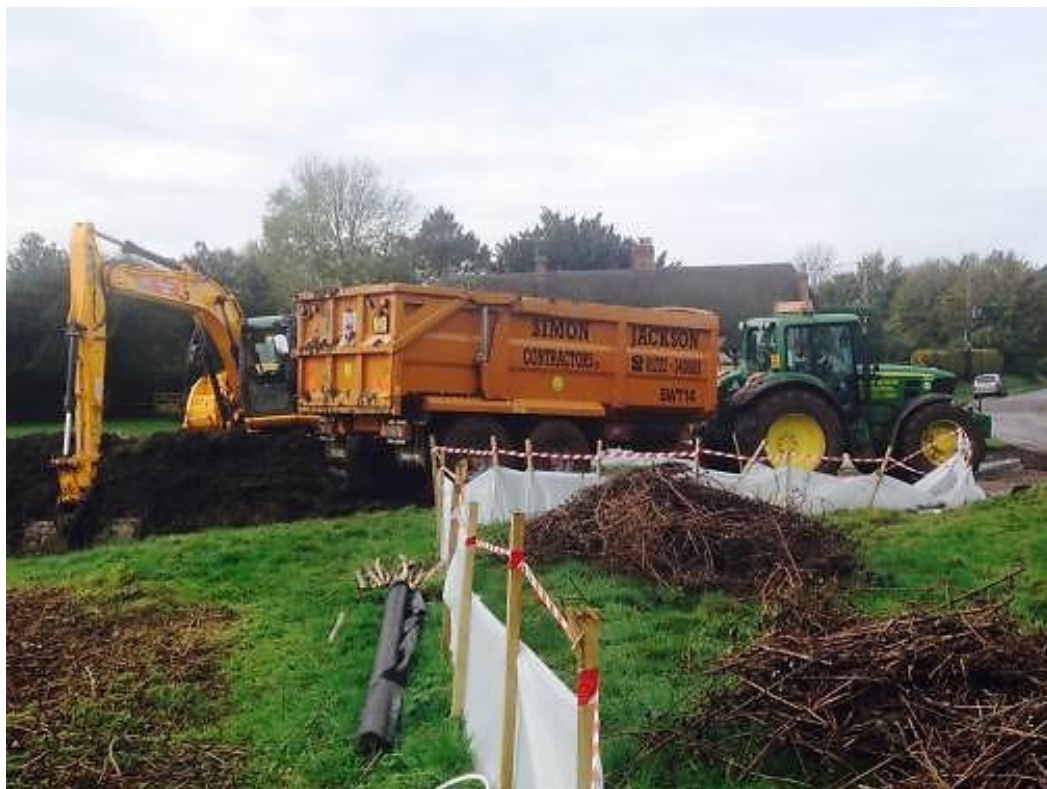
**Figure 33:** Excavation of Round Pond during Autumn 2014 (Photograph: Joanne Gore)

**Figure 34:** Excavation of Round Pond during Autumn 2014 (Photograph: Joanne Gore)

**Figure 35:** Excavation of Round Pond during Autumn 2014 (Photograph: Joanne Gore)

**Figure 36:** Excavation of Round Pond during Autumn 2014 (Photograph: Joanne Gore)
