# **Control of the Invasive Non-Native Creeping Water Primrose at Breamore Marsh, Hampshire**

Report relating to the first ten years 2009 - 2019

**Catherine Chatters and Joanne Gore**  
**New Forest Non-Native Plants Project**  
December 2019

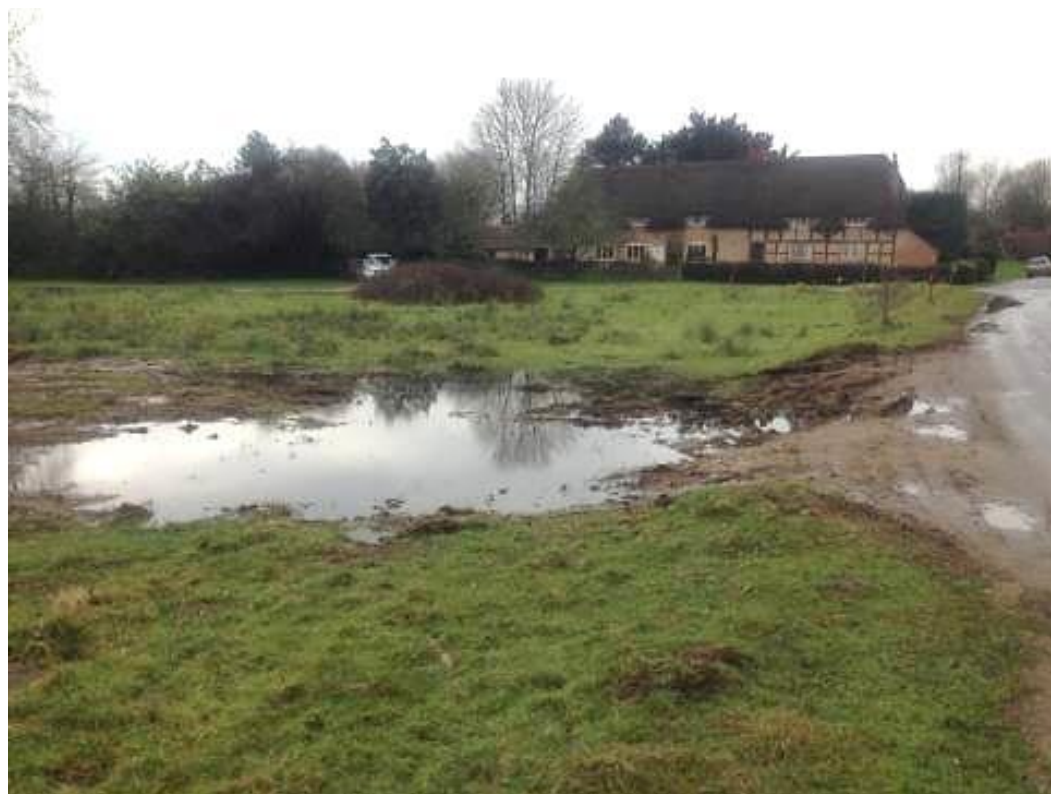
**Figure 37:** Small area of compaction on edge of Breamore Marsh SSSI (Photograph: Joanne Gore)

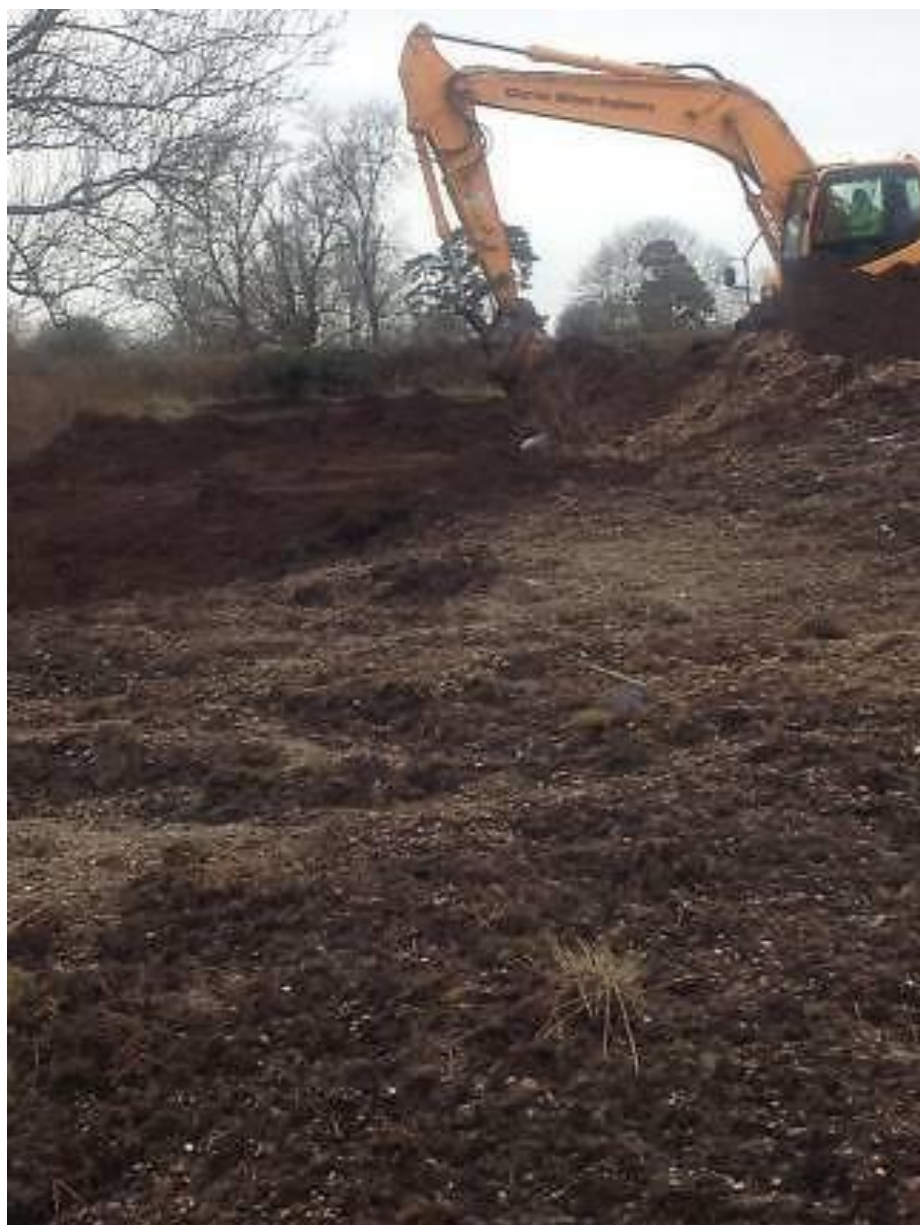
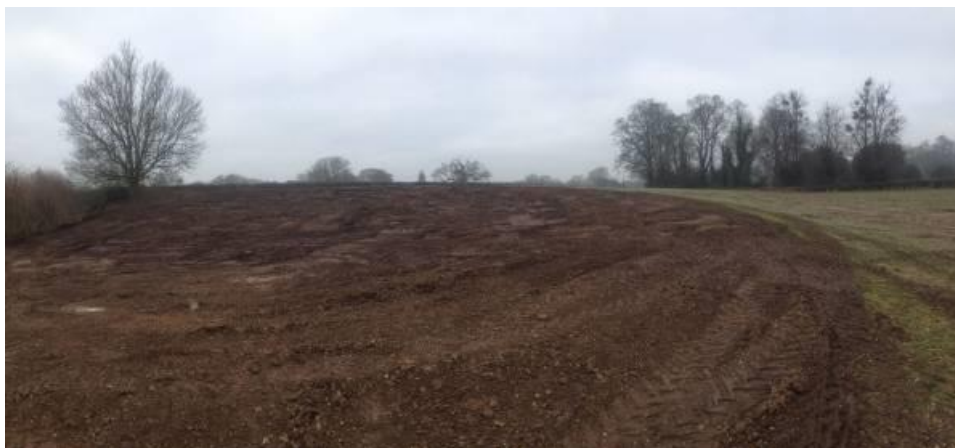
**Figure 38:** Capping the disposal site during February 2015  
(Photograph: Joanne Gore)

**Figure 39:** The disposal site after capping (Photograph: Joanne Gore)

The capping of the disposal site (to fulfil the conditions of the Local Enforcement Decision and the planning permission) could not take place immediately after the excavation work was completed, due to unfavourable ground conditions. The disposal site was capped on 5 and 6 February 2015 during a period of frosty weather which facilitated access to the field and avoided rutting. Material which had been scraped from the site was used to cap the hole to a depth of at least 20cm (Figure 38 and Figure 39).

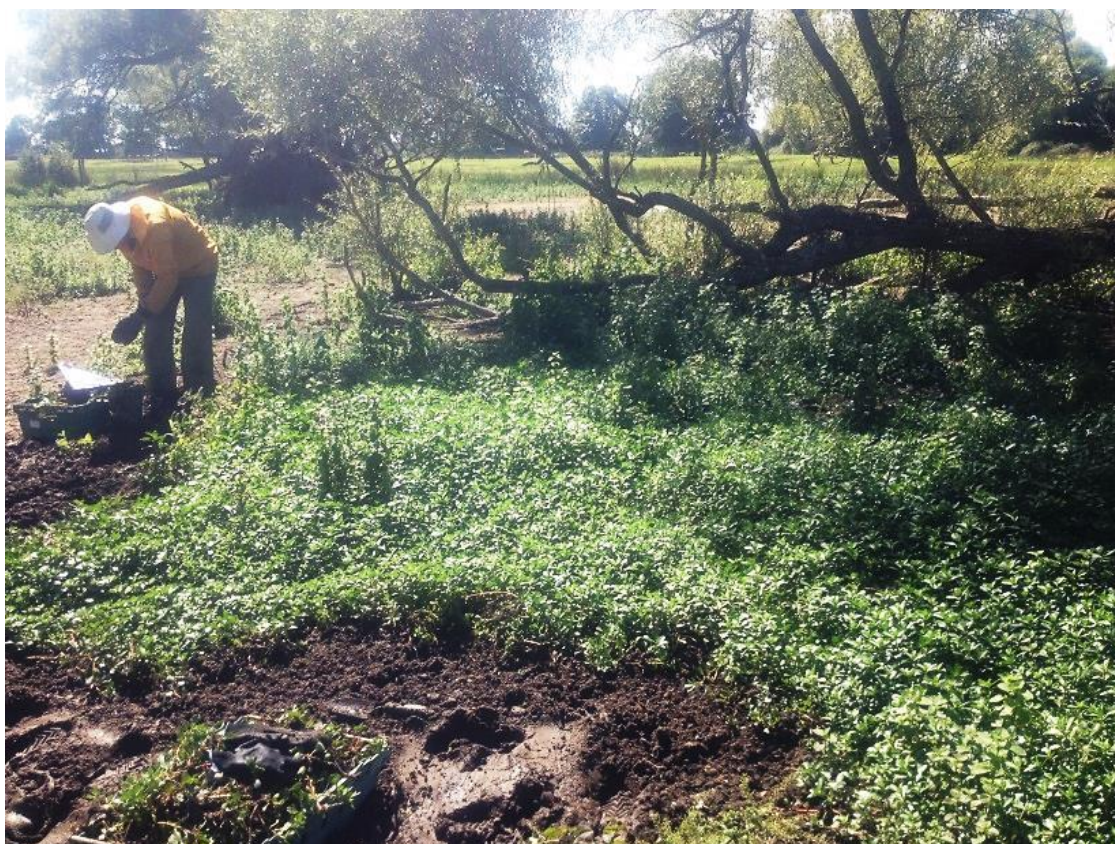
- 23 August 2016 – the Project Officer visited Breamore Marsh with a volunteer who discovered creeping water primrose also growing in an adjacent pond (referred to as Lower Pond). The patch in Lower Pond was approximately 2 x 3 metres which was too large for it to be removed in its entirety. In the circumstances plants were removed from the outer edge of the patch (Figure 41).

**Figure 41:** Volunteer Brian Matthews hand-pulling creeping water primrose in Lower Pond on 23 August 2016 (Photograph: Joanne Gore)

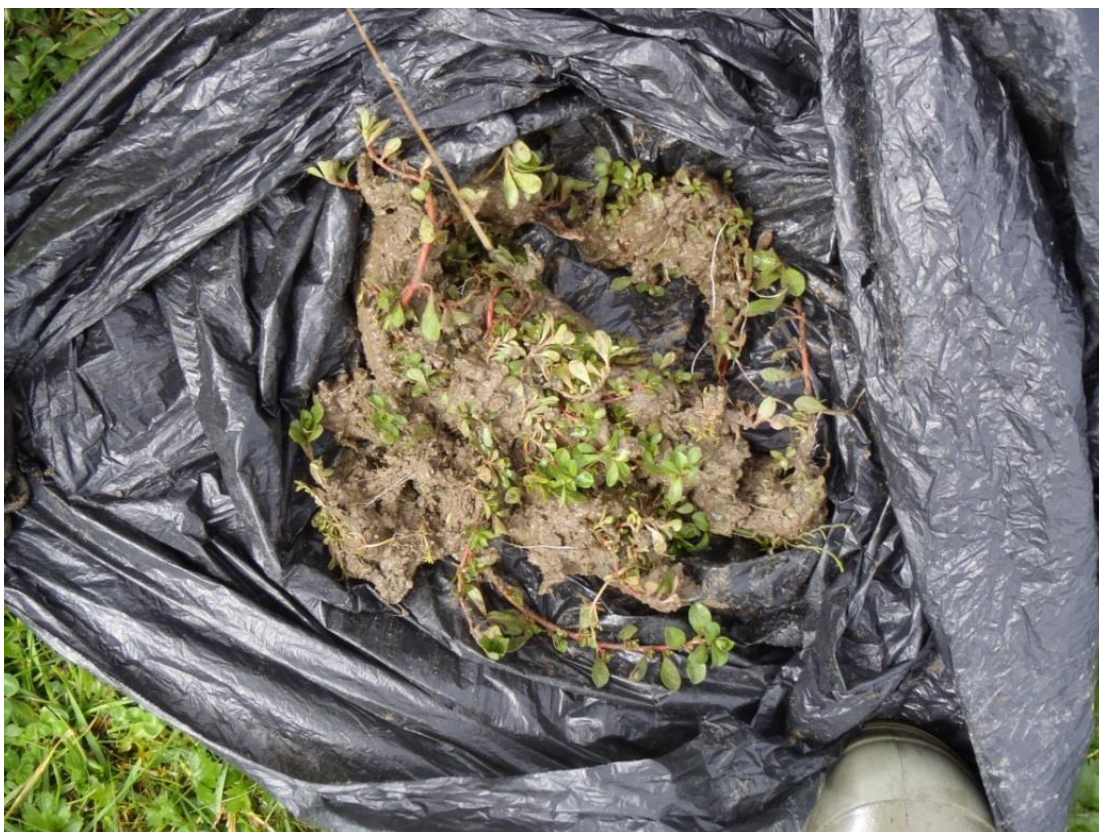
- 3 August 2017 – a 'few small sprigs' of creeping water primrose were found in Round Pond. No creeping water primrose found in Lower Pond but water levels had risen (Figure 46 and Figure 47).

**Figure 47:** creeping water primrose found in Round Pond on 3 August 2017  
(Photograph: Joanne Gore)

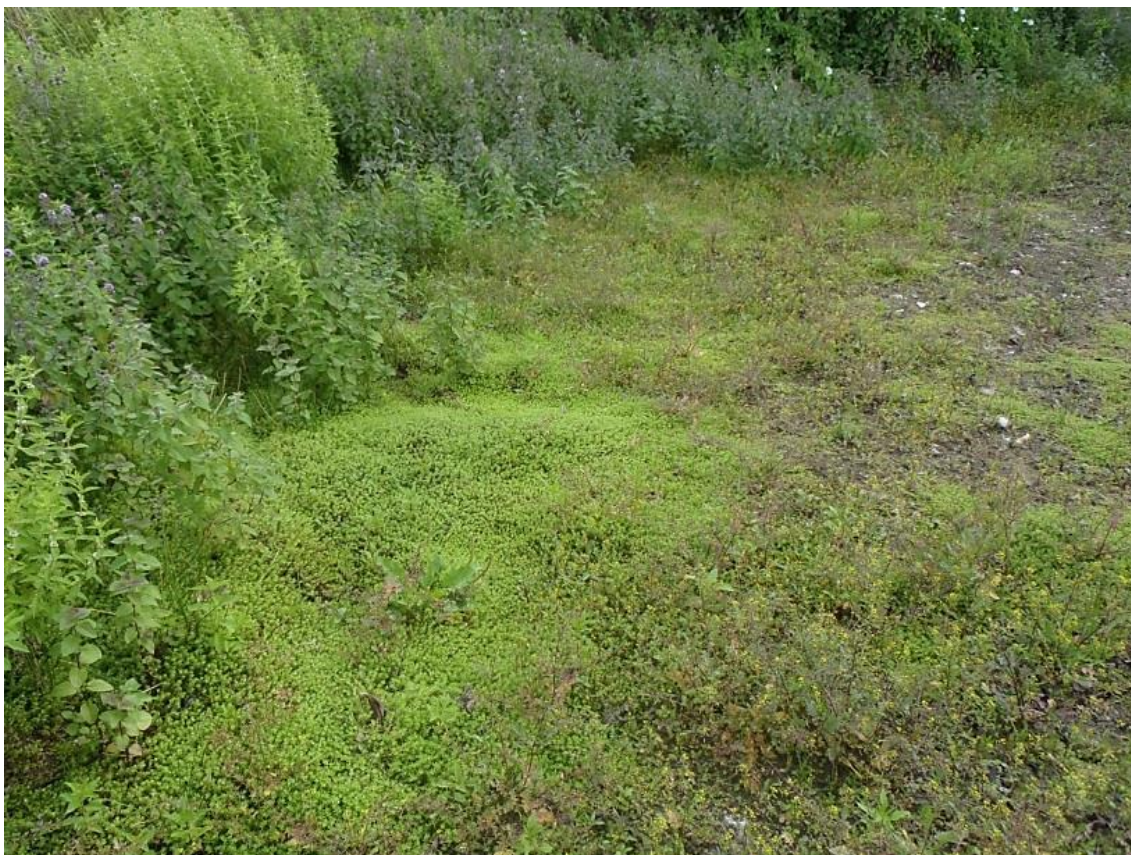
- 22 September 2017 – creeping water primrose was found within large mounds of *Crassula helmsii* at the edge of Round Pond. Also some fragments of creeping water primrose were found, for the first time since the excavation work, in exposed areas in the middle of the pond. The margins of Round Pond had become increasingly more difficult to check due to the colonisation by native plants and extensive areas of *C. helmsii*. One flowering plant of creeping water primrose and 'a few small sprigs' of creeping water primrose were found in Lower Pond which was sufficiently dry to be monitored but where dense growth of water mint affected the thoroughness of the search. (Figure 48).

**Figure 48:** By 22 September 2017 the margins of Round Pond had become difficult to check for creeping water primrose due to extensive growth of *Crassula helmsii* (Photograph: Joanne Gore)

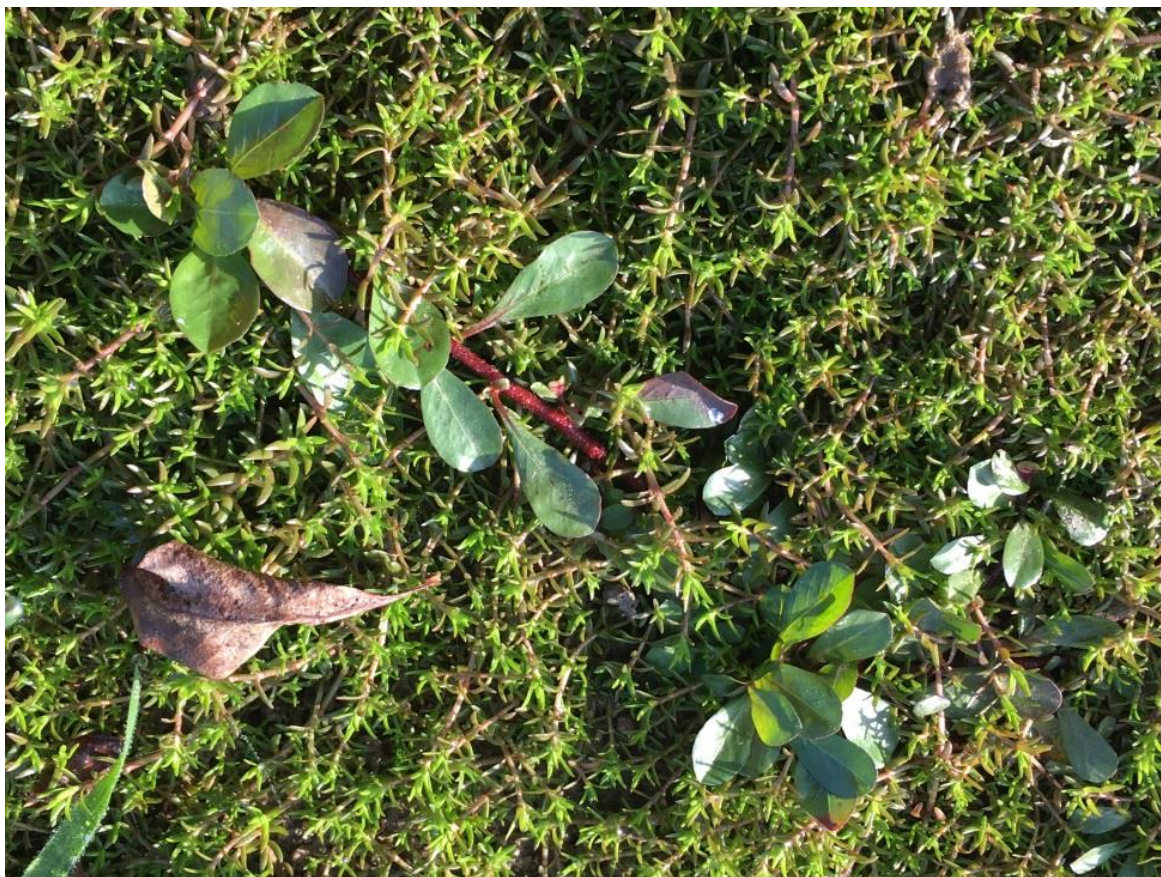
- 2 November 2017 – 4 'small sprigs' of creeping water primrose found in Round Pond (Figure 50). No creeping water primrose found in Lower Pond.
- 15 November 2017 – 'a couple of sprigs' of creeping water primrose were found in Round Pond where water level was very high (Figure 51). The disposal site was monitored; the re-seeded area was covered with nettles which made it difficult to survey but it 'had remained stable and intact'. There were no signs of any invasive non-native plants and the surrounding land had been brought back into arable cultivation (Figure 52).

**Figure 50:** Some of the creeping water primrose found in Round Pond on 2 November 2017 (Photograph: Joanne Gore)

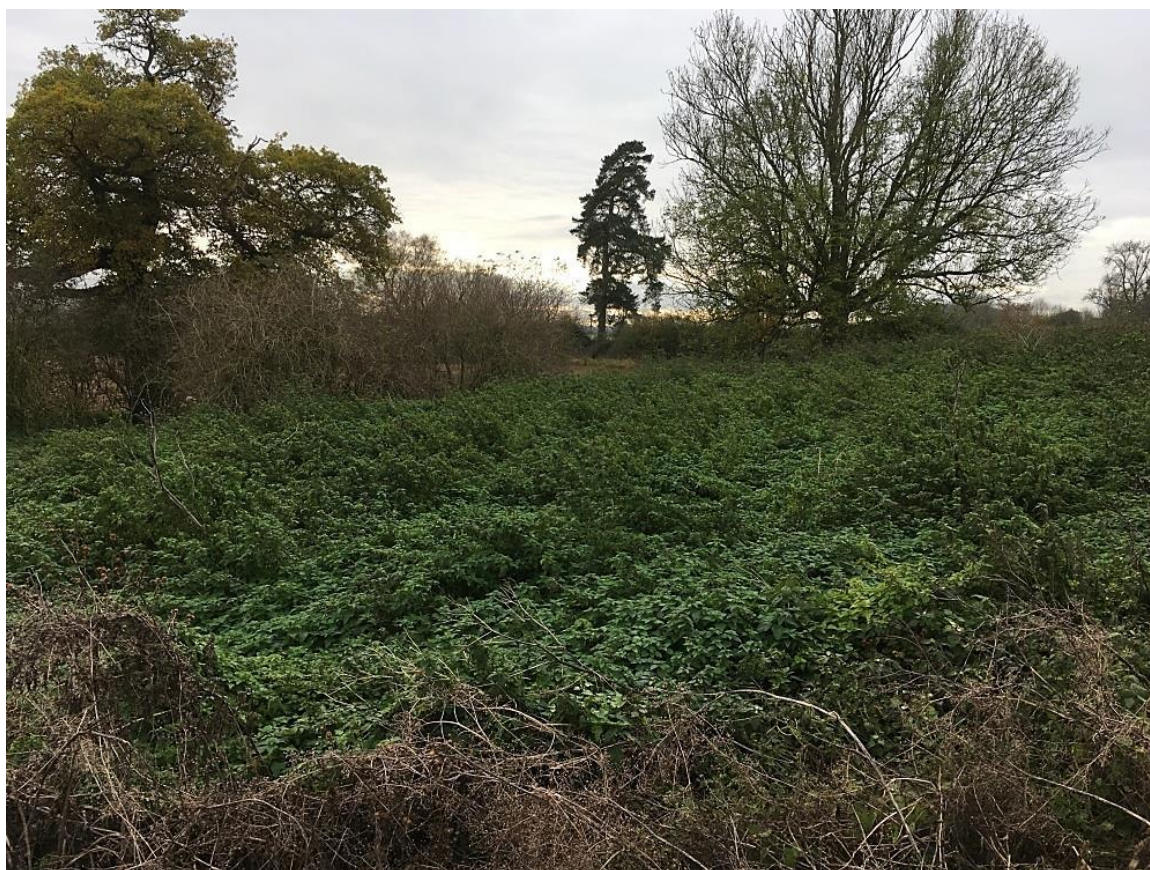
**Figure 52:** The disposal site was monitored on 15 November 2017 (Photograph: Joanne Gore)

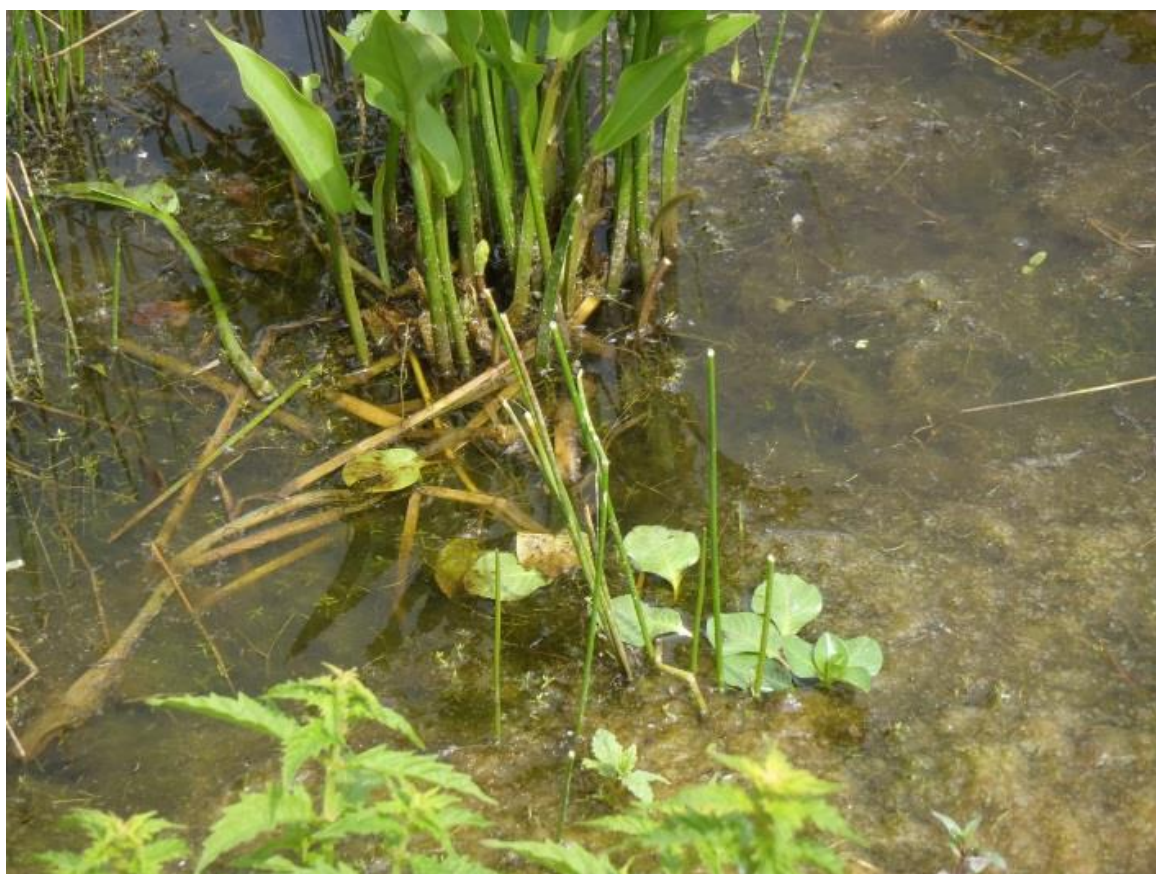
- 5 July 2018 – 15 'strands/seedlings' of creeping water primrose found in Round Pond, all confined to the margins of the pond but not confined to one particular area (Figure 53). Part of Lower Pond was monitored but high water level and dense growth of water mint prevented a thorough check.

**Figure 53:** Some of the creeping water primrose found in Round Pond on 5 July 2018  
(Photograph: Joanne Gore)

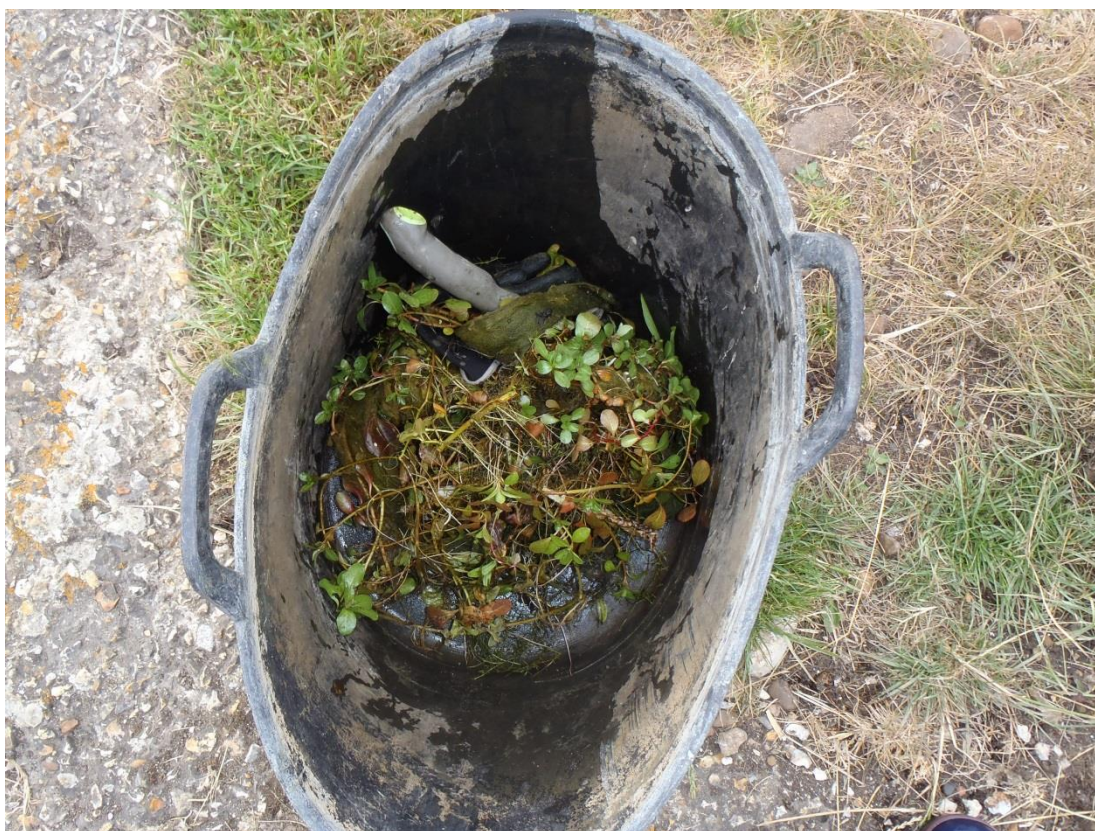
- 19 July 2018 – approximately 20 'strands' of creeping water primrose were removed from Round Pond (Figure 54 and Figure 55). No creeping water primrose found in Lower Pond.

**Figure 55:** Creeping water primrose removed from Round Pond on 19 July 2018 (Photograph: Joanne Gore)

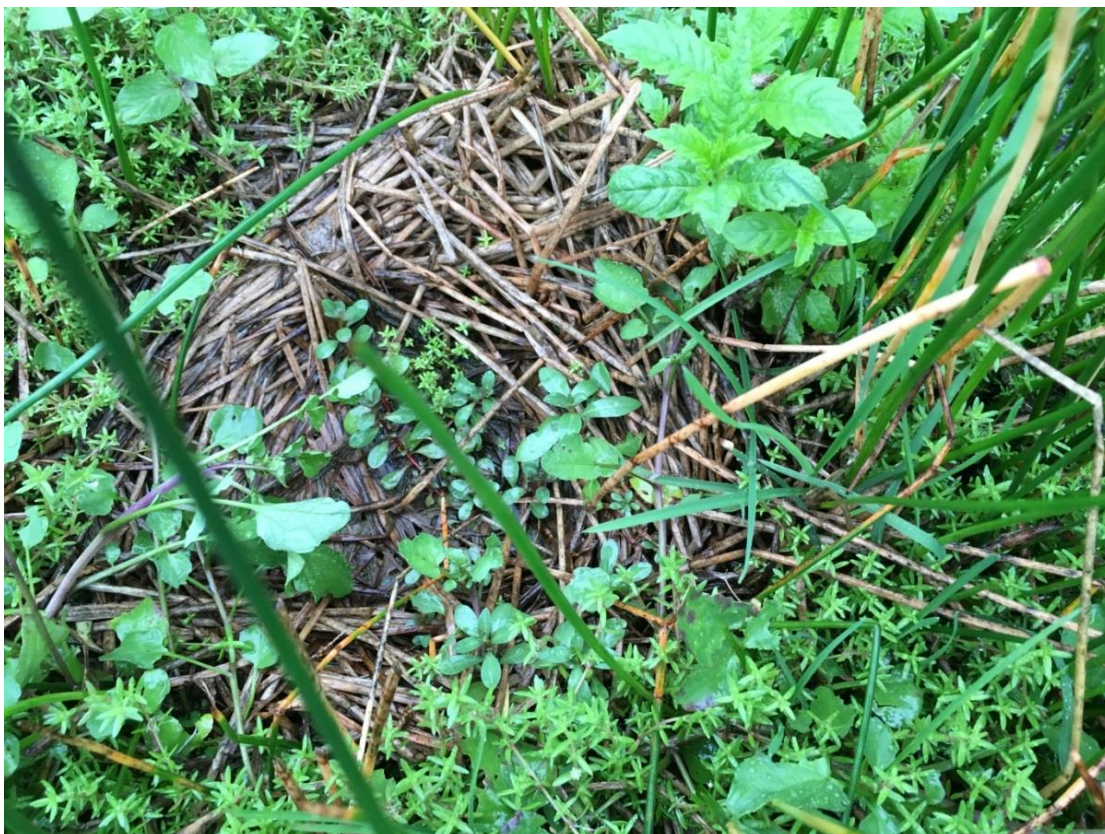
**Figure 56:** Creeping water primrose growing in moorhen nest in Round Pond on 16 August 2018 (Photograph: Joanne Gore)

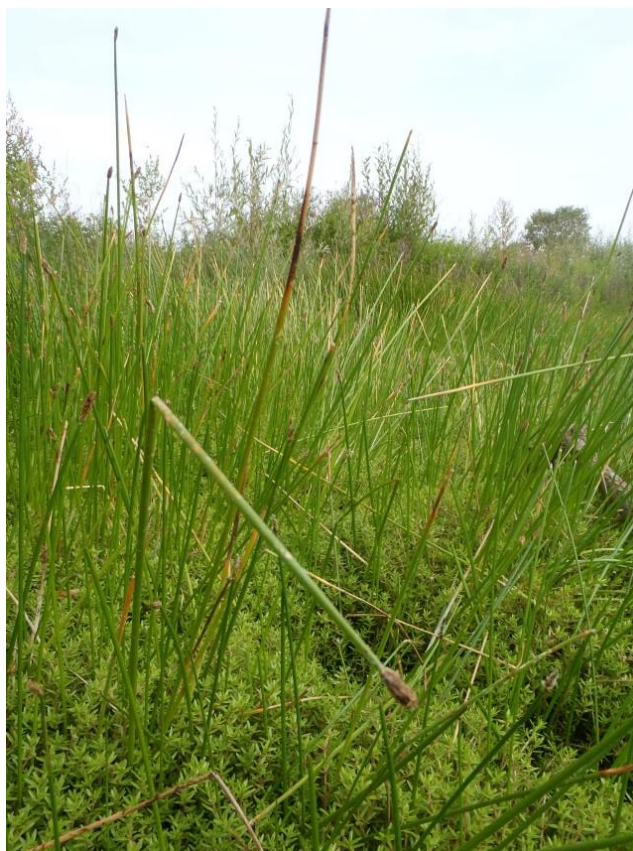
- 16 August 2018 – water levels in Round Pond had fallen but were still higher than normal and 'vast amounts' of *C. helmsii* hampered surveillance. One flowering plant of creeping water primrose was found amongst marginal vegetation. In total approximately 15 – 20 plants of creeping water primrose were found, filling approximately one third of a tub. Some creeping water primrose was found in a moorhen nest and some found within *C. helmsii* (Figure 56 and Figure 57). No creeping water primrose was found in Lower Pond.

**Figure 57:** *Crassula helmsii* in Round Pond on 16 August 2018 (Photograph: Joanne Gore)

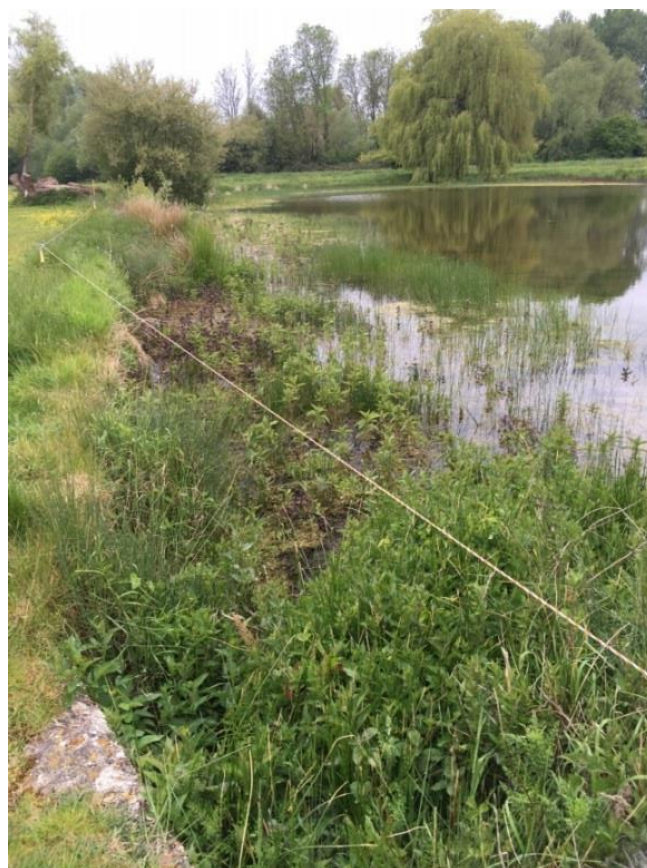
**Figure 58:** No creeping water primrose was found in Round Pond on 13 June 2019 (Photograph: Joanne Gore)

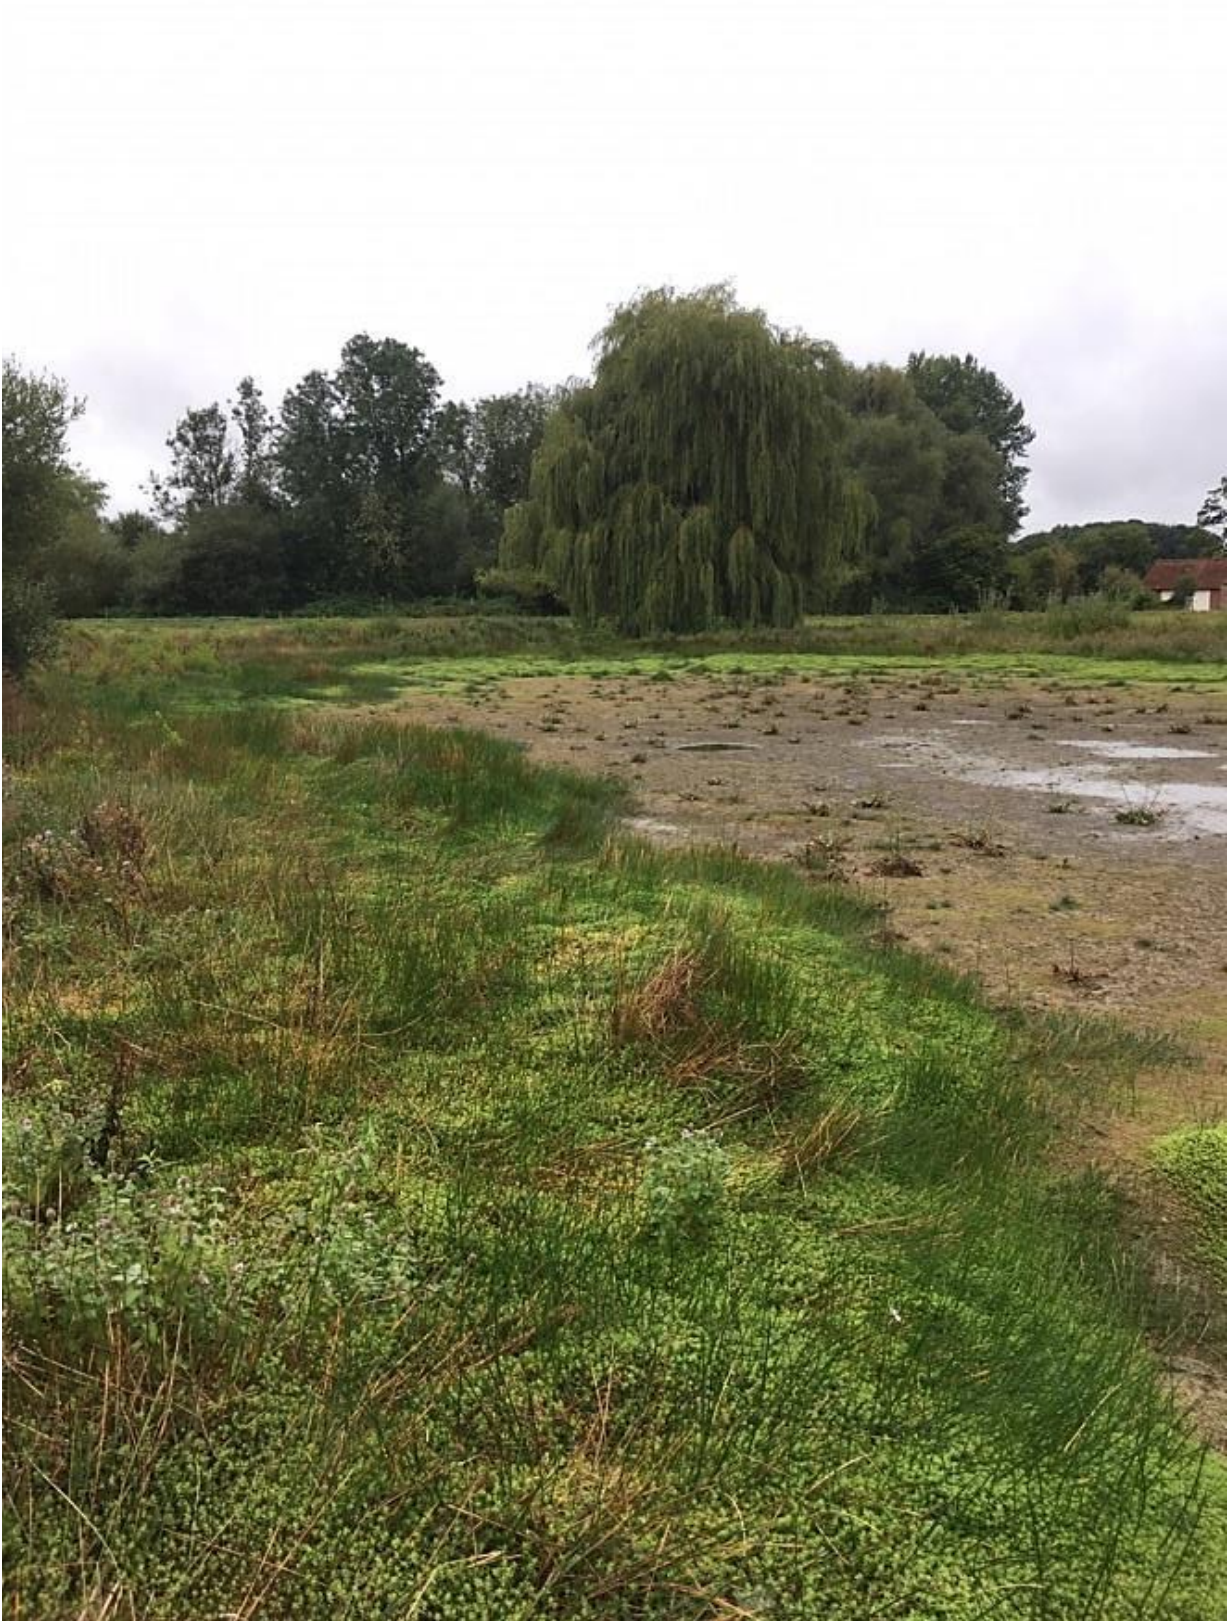
**Figure 59:** Round Pond was almost completely dry on 19 July 2019 (Photograph: Joanne Gore)

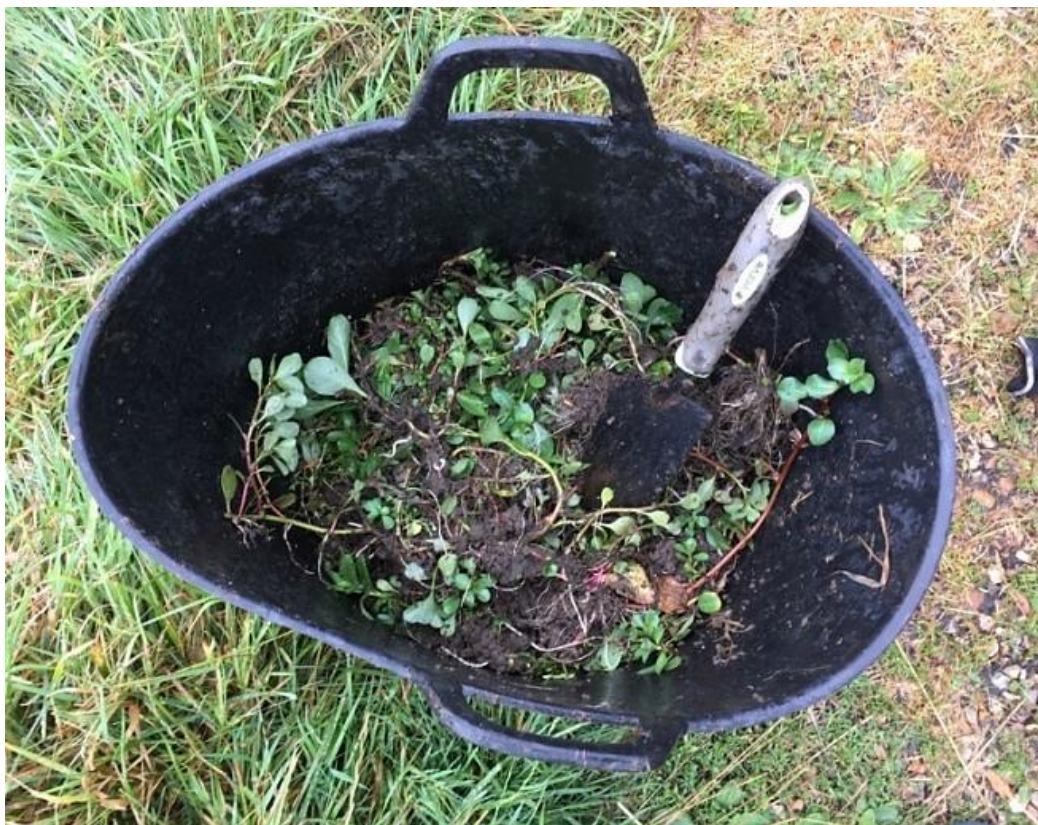
**Figure 60:** Creeping water primrose removed from Lower Pond on 19 July 2019 (Photograph: Joanne Gore)

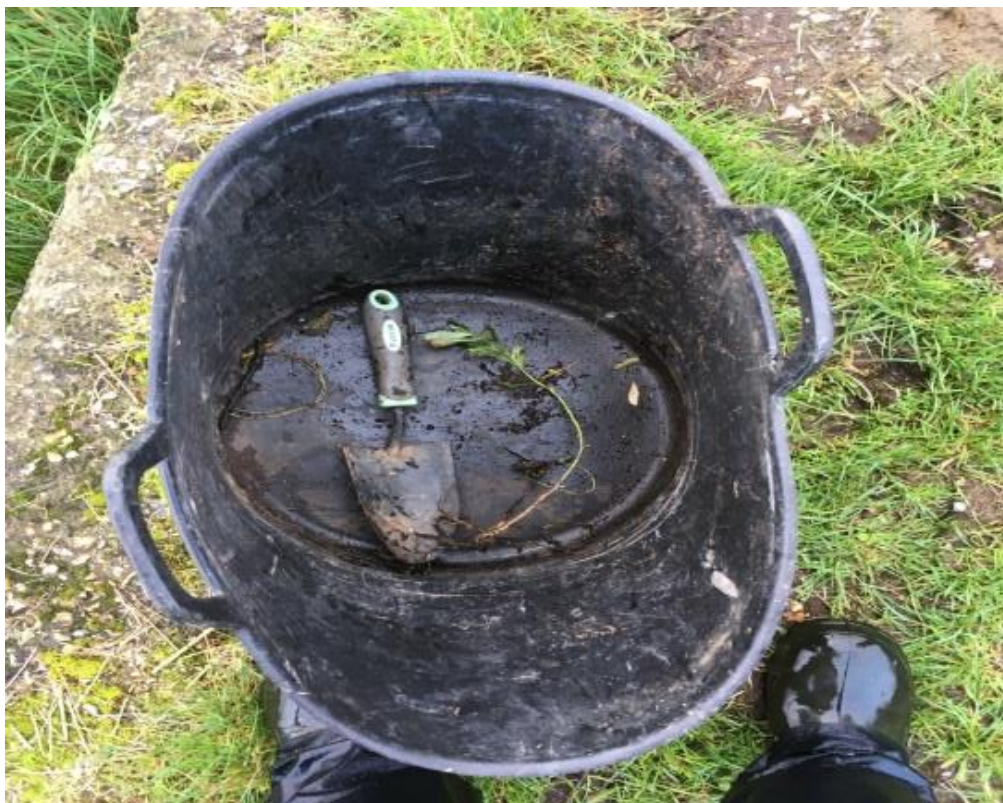
**Figure 61:** The single 'sprig' of creeping water primrose found in Round Pond during monitoring visit on 15 October 2019 (Photograph: Joanne Gore)

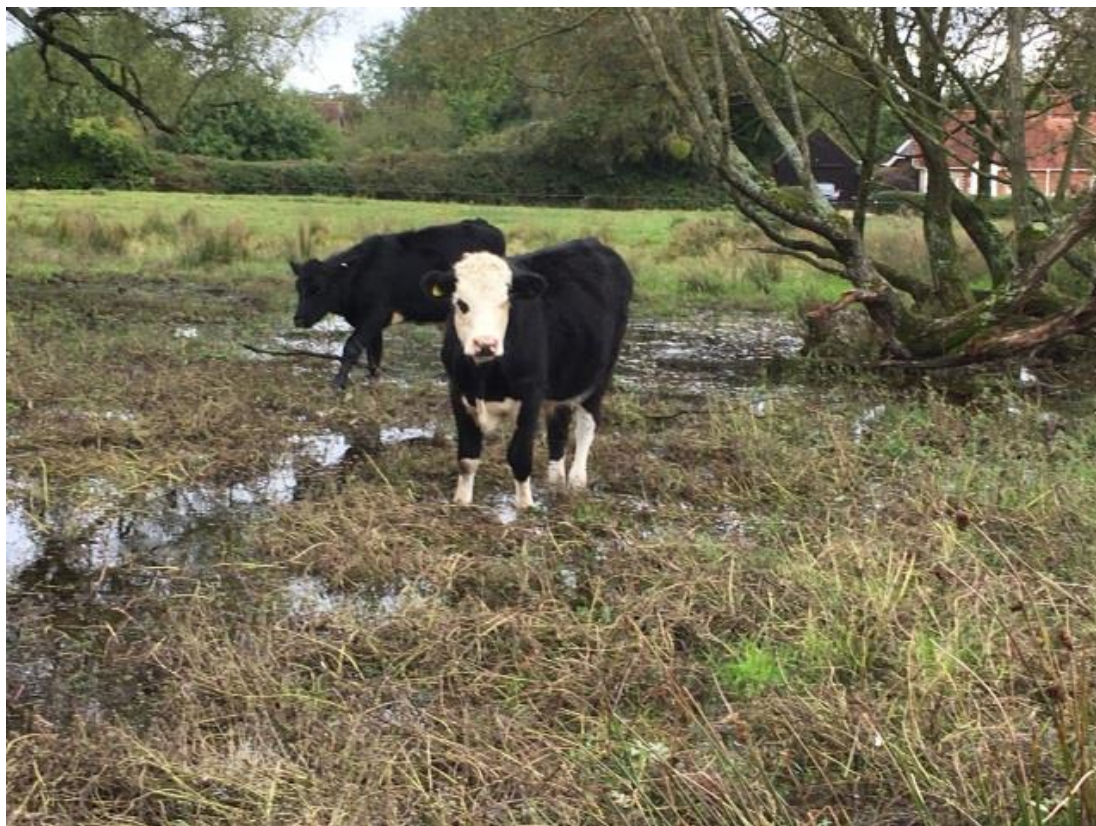
**Figure 62:** Monitoring of Lower Pond was much easier on 15 October 2019 as cattle had grazed the dense growth of water mint (Photograph: Joanne Gore)
